## **DOT/FAA/AR-06/23**

# **Airside Applications for Artificial Turf**

June 2006

Final Report

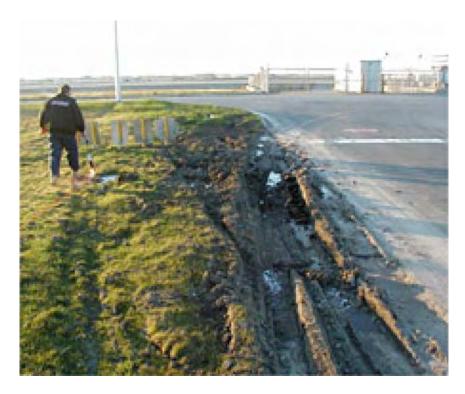
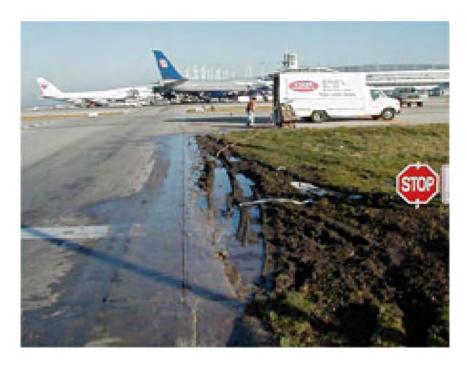
FIGURE 2-1. PROBLEM AREA AT TAXIWAY D2 (ORD) VIEW 1

FIGURE 2-2. PROBLEM AREA AT TAXIWAY D2 (ORD) VIEW 2

In December 2001, ORD was one of the first airports to consider artificial turf as a way to mitigate a reoccurring soil stability issue. Near taxiway D2 (figures 2-1 and 2-2 and appendix A, figure A-1) was chosen for a test installation site because airport service vehicles would frequently travel off the access road near the taxiway and onto the grass, tracking mud and dirt onto the runways. The turf was installed as shown in figures 2-3 and 2-4. Airport service vehicles have been trafficking across the area since the installation, and no additional maintenance to the turf or to the airport pavement surfaces, outside of regular maintenance schedules, has been needed.

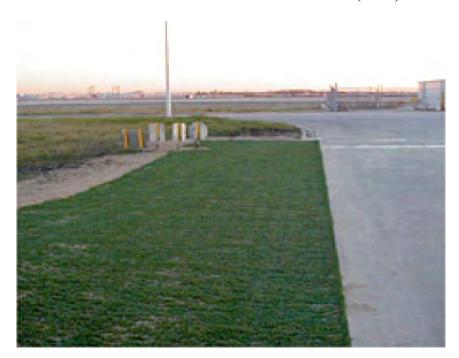
FIGURE 2-3. ARTIFICIAL TURF INSTALLED AT TAXIWAY D2 (ORD)

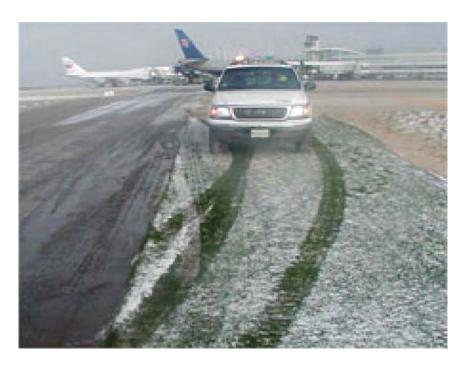
FIGURE 2-4. ARTIFICIAL TURF AT ORD TAXIWAY D2

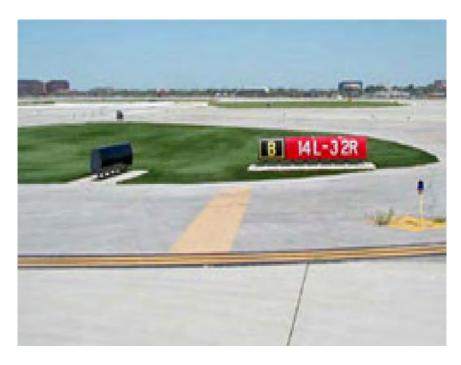
FIGURE 2-5. ARTIFICIAL TURF INSTALLATION AT ORD RUNWAY 14L/32R

A second erosion test location for the artificial turf was placed over the entire island at the end of runway 14L/32R, as shown in figure 2-5. The island subgrade was angled at a 3% grade off the island edge to direct the water flow to the drain located in the center of the island. Airport maintenance workers stated that there have been no problems with any type of erosion or water pooling at this location since the installation.

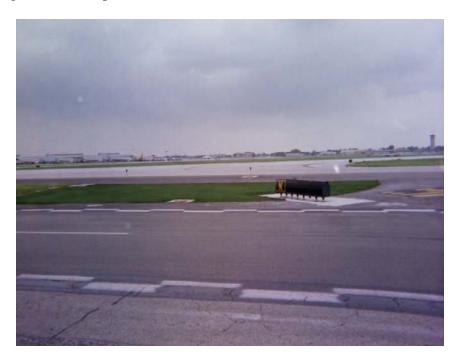
FIGURE 2-6. ARTIFICIAL TURF INSTALLATION AT MDW NEAR TAXIWAY N

MDW experienced a similar erosion problem at a turnoff near taxiway N. The area was eroding as a result of the jet blast of passing aircraft. Airport operations staff decided to test the artificial turf to mitigate this problem and installed a section in June 2001, as shown in figure 2-6 and appendix A, figure A-2. No problems have been recorded since the artificial turf was installed.

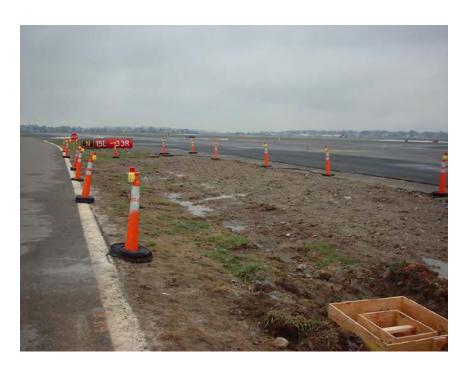
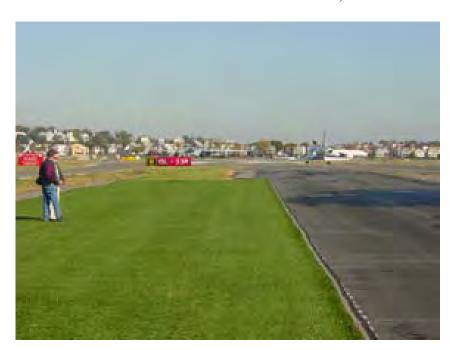
FIGURE 2-7. TEST LOCATION AT BOS TAXIWAY N, PREINSTALLATION

FIGURE 2-8. TEST LOCATION AT BOS TAXIWAY N, POSTINSTALLATION

On June 6, 2003, BOS installed a 9000-ft<sup>2</sup> test section on taxiway N near runway 15L/33R, as shown in figures 2-7 and 2-8 and appendix A, figure A-4 where erosion, drainage, and winter sand buildup was excessive. Airport personnel had to close runway and taxiway operations to rework the soil. The shutdowns were becoming too costly, so an area of artificial turf was installed as a possible solution. Two strips of turf were sewn together and installed on the island next to taxiway N from the points were the most rutting and erosion occurred, with natural grass still surrounding the installation. A French drain outside the taxiway object free zone runs along the backside of the turf and leads to a drain along the edge of the artificial turf. Since the artificial turf has been installed, there has not been a reoccurrence of the issues.

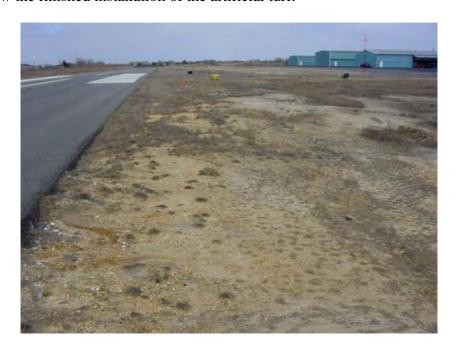
FIGURE 2-9. TEST PLOT LOCATION PRIOR TO ARTIFICIAL TURF INSTALLATION ON RUNWAY 6/24 (SOIL EROSION)

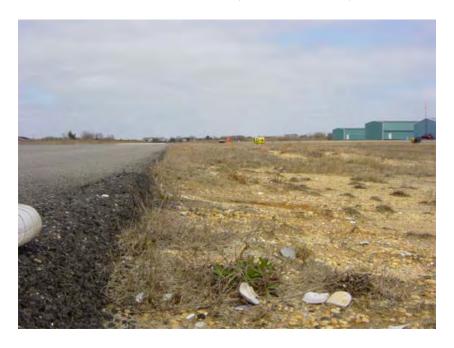
FIGURE 2-10. CLOSE-UP VIEW OF SOIL EROSION ALONG THE EDGE OF RUNWAY 6/24

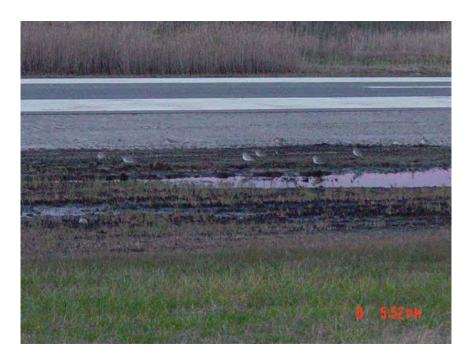
FIGURE 2-11. PONDING WATER ALONG THE EDGE OF RUNWAY 6/24 ADJACENT TO ARTIFICIAL TURF INSTALLATION LOCATION

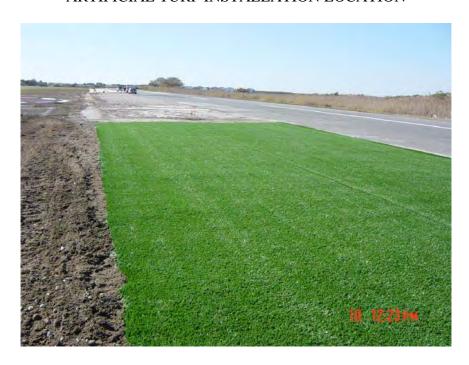
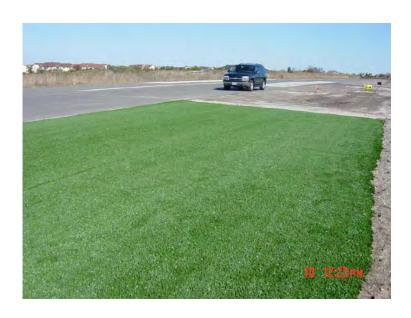
FIGURE 2-12. ARTIFICIAL TURF INSTALLATION ALONG THE EDGE OF RUNWAY 6/24 VIEW 1

FIGURE 2-13. ARTIFICIAL TURF INSTALLATION ALONG THE EDGE OF RUNWAY 6/24 VIEW 2

and high-tide conditions, the bay floods and the excess water spills over the runway, eroding the soil between the runway and taxiway. The proposed location of the artificial turf installation is an area that experienced heavy soil erosion directly along the edge of the runway. Figures 2-12 and 2-13 show the finished installation of the artificial turf.

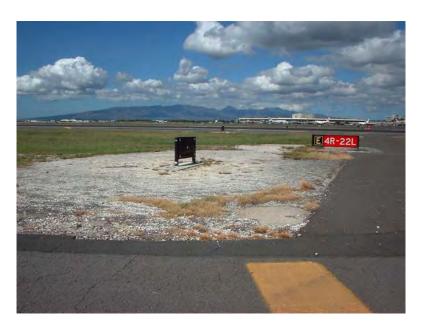
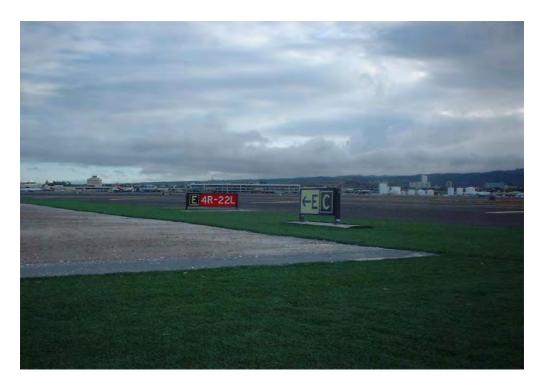
FIGURE 2-14. SITE VIEW PRIOR TO INSTALLATION OF ARTIFICIAL TURF (HNL)

FIGURE 2-15. SITE VIEW WITH ARTIFICIAL TURF INSTALLED (HNL)

In June 2003, HNL personnel decided to install the artificial turf (see figures 2-14 and 2-15 and appendix A, figure A-3) to stop the coral from being blown onto the pavement areas. HNL was experiencing shutdowns on taxiway E, a major taxiway, every time a Boeing 747 taxied by. The site previously had a large amount of loose coral, and when a B-747 taxied by the location, the outboard engine would blow the loose coral onto the taxiway and runway 4R-22L. Deemed a major FOD hazard by airport personnel, the airport would have to shutdown the area to conduct proper clean up.

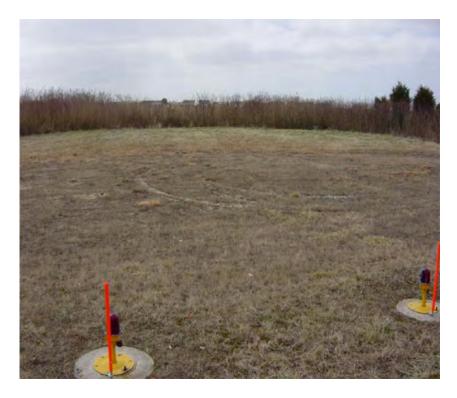
FIGURE 2-16. TEST PLOT LOCATION PRIOR TO ARTIFICIAL TURF INSTALLATION IN RUNWAY SAFETY AREA

Ocean City Municipal Airport (see appendix A, figure A-7) does not have a staff to maintain the grass runway safety area at the end of runway 6, as shown in figure 2-16. Therefore, the effort had to be contracted out on a regular basis. Cutting the grass in that area frequently led to the replacement of the eight end runway lights. Ocean City decided to install artificial turf to reduce the grass cutting and light replacement costs. The installation area was 3000 ft<sup>2</sup>. Figures 2-17 and 2-18 show the final installation of the artificial turf.

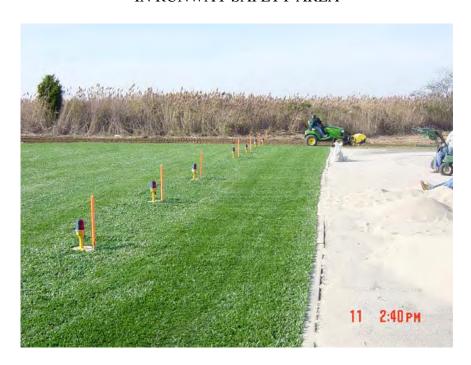
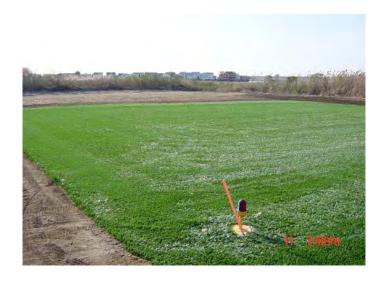
FIGURE 2-17. TEST PLOT LOCATION DURING ARTIFICIAL TURF INSTALLATION IN RUNWAY SAFETY AREA

FIGURE 2-18. TEST PLOT LOCATION AFTER ARTIFICIAL TURF INSTALLATION IN RUNWAY SAFETY AREA

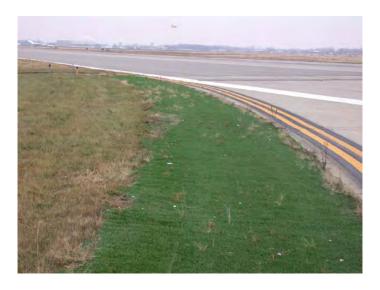
FIGURE 2-19. TEST LOCATION AT DTW RUNWAY 4R/22L, POSTINSTALLATION

In June 2002, DTW installed a second test section of artificial turf adjacent to a drainage problem area. This test section was installed to mitigate soil erosion caused by jet blast on a shoulder to the main carrier runway 4R/22L (see figure 2-19 and appendix A, figure A-5). Complaints had been filed by the Airline Pilots Association, airline tenants, and the FAA regarding large plumes of dust created by a B-747-400 aircraft following takeoff. Air traffic controllers eventually deemed it necessary to increase separation of departures following heavy aircraft. The previous modus of addressing this problem by the airport was installing topsoil and hydroseeding, which proved to be a very short-term resolution.

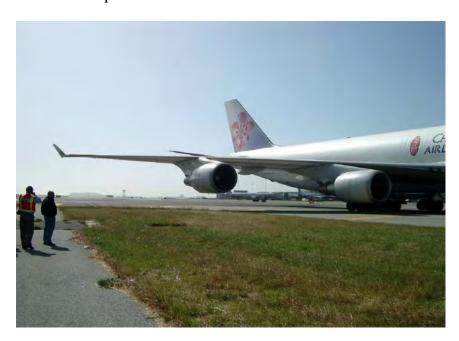
FIGURE 2-20. TEST PLOT LOCATION PRIOR TO ARTIFICIAL TURF INSTALLATION

In May 2004, SFO (see figure 2-20 and appendix A, figure A-6) was looking for a solution to its natural grass problems that included jet blast soil erosion at the high-speed turnoff at taxiway K and FOD debris from the B-747 outboard engine blowing natural grass and dirt onto runway 28L-10R. The airport operator decided that the runway and taxiway shutdowns necessary to rework the soil were becoming too costly. A test plot (approximately 10,000 ft<sup>2</sup>) of artificial turf was installed to alleviate the problem.

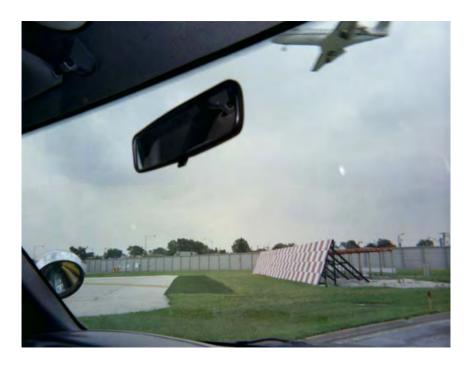
FIGURE 2-21. INSTALLATION AT BLAST PAD NEAR RUNWAY 31C (MDW)

MDW installed artificial turf at the blast area of runway 31C (see figure 2-21 and appendix A, figure A-2) in June 2001. This installation was not used to solve any problem, but to test the durability of the turf. The idea was to determine how the artificial turf would react with everyday airport usage. To date, the test strip has not become dislodged, caused any FOD damage, or shown any signs of uplift or movement.

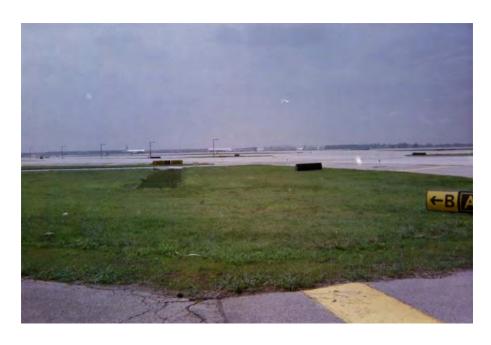
FIGURE 2-22. ARTIFICIAL TURF INSTALLATION AT ORD TAXIWAYS A6 AND A7

In December 2001, ORD also installed a test area on the island between taxiways A6 and A7 (see figure 2-22 and appendix A, figure A-1) where water runoff from heavy rain and melting snow pooled around a drain and saturated the soil. Concreting the entire area between the taxiway and runway had been tried previously but water pooled at the drain because there was nothing to slow down the water flow (and it was noted that the concreting diminished the visual distinction between the runway and taxiway). A single strip of artificial turf was installed from the top of the island to the drain. This strip replaced most of the existing eroded and rutted grass. Airport staff noted that the strip of artificial turf slowed the flow of water similar to natural grass, but the surrounding area did not become over saturated, allowing water to stand on the surface until it was absorbed or evaporated.

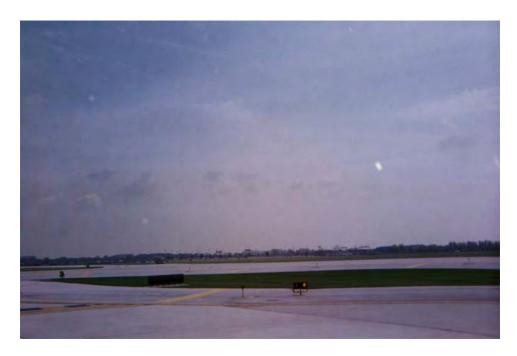
FIGURE 2-23. ARTIFICIAL TURF ON AN ISLAND ADJACENT TO RUNWAY 32R (ORD)

Also at ORD, a second installation of artificial turf was placed over the entire island that separated runway 32R from taxiway P, as shown in figure 2-23. The island subgrade was angled so that the water flowed to the drain located in the center of the island. Airport maintenance workers stated that there have been no problems with any type of erosion or water pooling at this location.

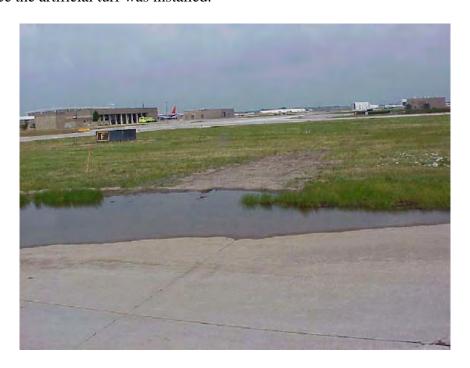
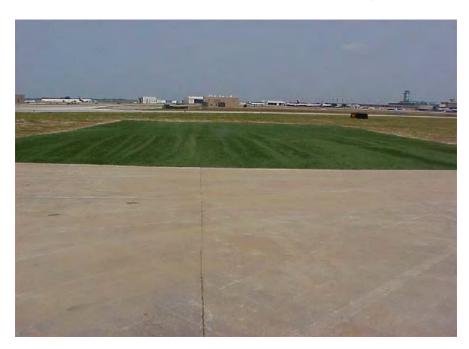
FIGURE 2-24. TEST LOCATION AT DTW RUNWAY 4R/22L, PREINSTALLATION

FIGURE 2-25. TEST LOCATION AT DTW RUNWAY 4R/22L, POSTINSTALLATION

In June 2002, an artificial turf test section was installed at DTW to investigate a possible solution to a drainage problem that was causing water to pool on the shoulder of the main carrier runway 4R/22L (see figures 2-24 and 2-25 and appendix A, figure A-5). The airport addressed this

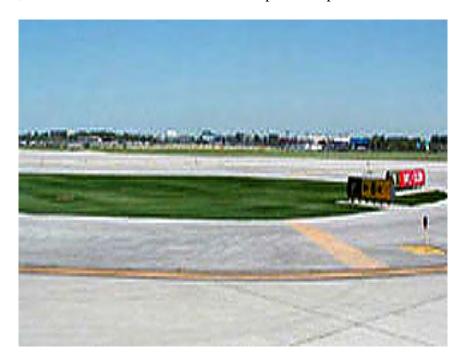
FIGURE 2-26. VISUAL ENHANCEMENT AT ORD

At ORD, an island located off taxiway M5 (near airline docking stations) had been painted green to provide some visual distinction of where a taxiway ended and a runway began, (see figure 2-26 and appendix A, figure A-1). However, after 1 or 2 years of use, the paint had faded and started to chip and peel. The airport found that it was too costly to shutdown and repaint the area every year, so an artificial turf was installed to replace the painted area.

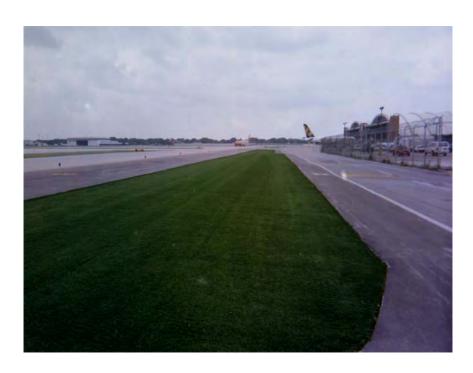
FIGURE 2-27. VISUAL ENHANCEMENT AT MDW

Aircraft returning to maintenance facilities located along taxiway N at MDW would sometimes veer onto a grass island that separated the maintenance facilities from the taxiway (see figure 2-27 and appendix A, figure A-2). MDW personnel theorized that the natural grass area was not providing enough visual distinction between the grassy and paved areas, so artificial turf was installed to test their theory. To date, no follow-up information has been obtained.

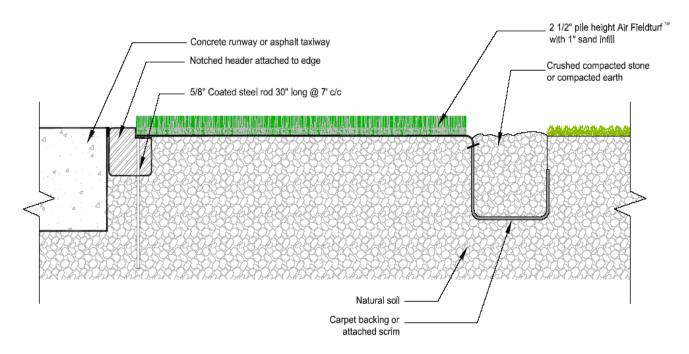
FIGURE 3-1. AIR FIELDTURF CROSS SECTION ON A LOAD-BEARING BASE

If the installation location of the artificial turf is on grass or soft soil, the area is excavated. If the area is in a critical area where aircraft loading is possible, the subgrade is compacted to be able to support the weight of one or two passes of the heaviest aircraft at the airport. This is done with an aggregate base course using both FAA P-209 and FAA P-154 (reference Advisory Circular 150/5370-10 for FAA aggregate information) materials compacted to 90-100 percent maximum density. A 6- by 6-recycled plastic notched curbing is attached to the ground with a 5/8-inch coated steel rod 30 inches long. The curbing is what attaches the turf flush with the adjoining pavement (see figures 3-1 through 3-4). To close the joint between the notched curbing and a runway or taxiway, a sealant is placed to prevent the growth of weeds and the intrusion of other foreign objects. The artificial turf is then layered over the compacted aggregate. Air FieldTurf uses a proprietary fiber and backing process. According to the manufacturer, this eliminates the need for a weed barrier to be put down prior to the turf installation. However, during the course of investigation, no tests were conducted by the FAA for drainage or weed growth. Air FieldTurf also installs both permeable and nonpermeable turf for use in the different areas within the confines of an airport environment, thus providing design alternatives for drainage runoff. The artificial turf surface is attached to the notched curbing with hot-melt glue, as recommended by the manufacturer, and fastened with galvanized or stainless steel nails. The adhesive acts as a gasket to seal the turf edge. The other side of the turf facing any grassy area is buried into the ground, secured with turf pegs, and compacted back-fill soil (see figures 3-1, 3-2, and 3-5). Once the turf surface is secured, sand is brushed into the entire surface to help act as ballast and to aid in fluid and debris retention (see figures 3-1, 3-2, and 3-6). If the installation site is wider than the manufactured turf width, sections of the artificial turf is sewn together, then placed in the installation site. Any excess artificial turf is trimmed.

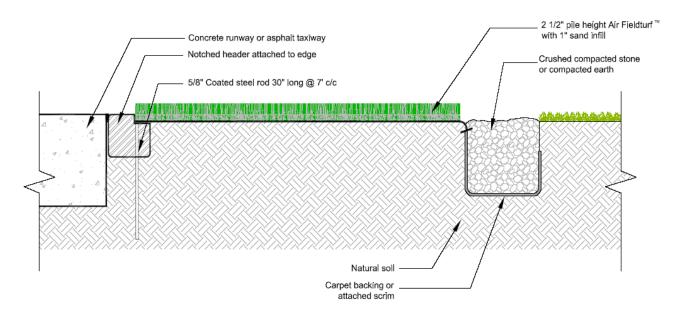
FIGURE 3-2. AIR FIELDTURF CROSS SECTION ON A NON-LOAD-BEARING BASE

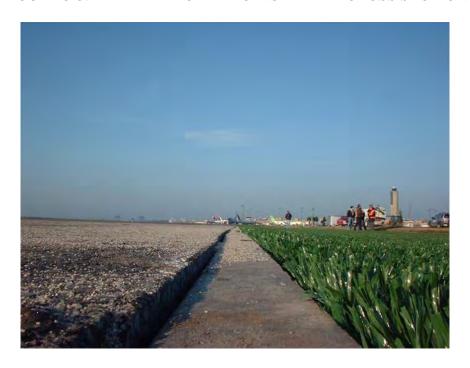
FIGURE 3-4. ARTIFICIAL TURF PAVEMENT SIDE ATTACHMENT

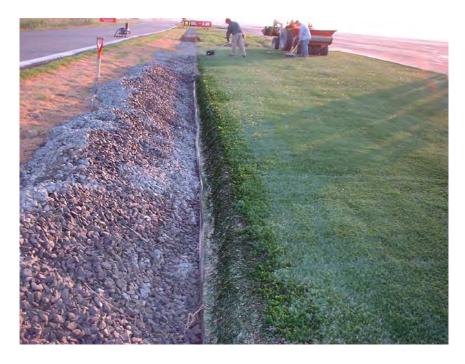
FIGURE 3-5. ARTIFICIAL TURF BACKSIDE TRENCHING AND ATTACHMENT

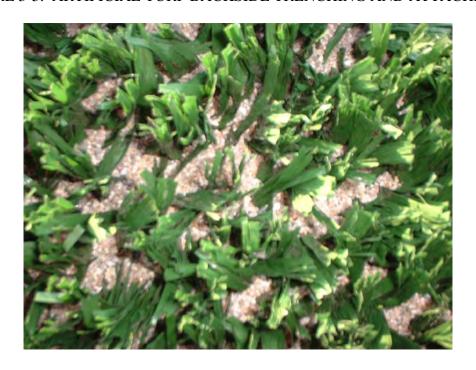
FIGURE 3-6. CLOSE-UP VIEW OF ARTIFICIAL TURF WITH BALLAST SAND, TOP VIEW

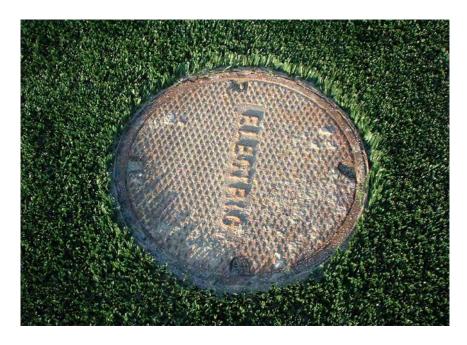
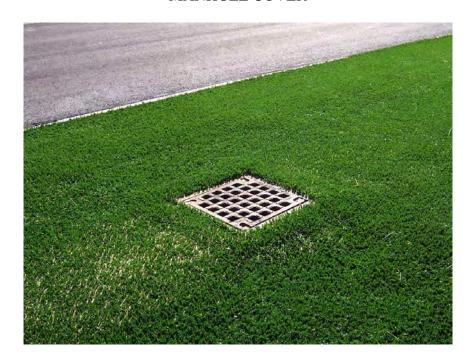
FIGURE 3-7. ARTIFICIAL TURF INSTALLED AROUND EXISTING MANHOLE COVER

FIGURE 3-8. ARTIFICIAL TURF INSTALLED AROUND EXISTING ACCESS DRAIN

Signs, manhole covers, access drains, and other existing airport markers (see figures 3-7 and 3-8) are not affected by the installation process because the artificial turf can easily be cut to fit the area that is needed. Air FieldTurf has a turf that has a Velcro seal specifically designed to permit access to future electrical or other airport equipment installations that would be buried under the turf.

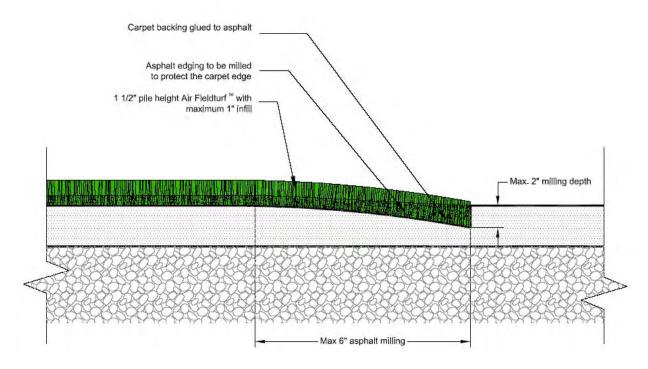
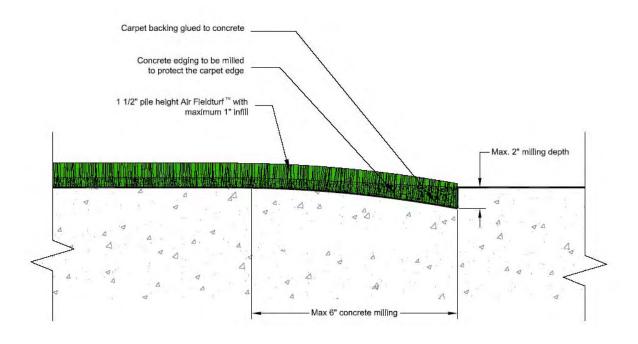
FIGURE 3-9. BURIED EDGE DETAIL FOR INSTALLATION ON ASPHALT

FIGURE 3-10. BURIED EDGE DETAIL FOR INSTALLATION ON CONCRETE

If the artificial turf is to be installed over concrete, as shown in figure 3-9, or asphalt, as shown in figure 3-10, the edge of the installation area will be milled to allow the turf edge to be placed below the existing surface, allowing a smooth transition of traffic across the turf (e.g., snow plows during winter months). Alternatively, a precast concrete ramp (see figure 3-11) will be placed on the hard surface and the turf edge to anchor the turf, allowing vehicular traffic to cross the turf edge without damage to the wheels. Additionally, the entire surface area of the installation site was coated with glue to provide an additional means to prevent the turf from dislodging. Currently, Air FieldTurf used two different types of glue: a two-part mixture called Environstick and Nordot 34N, shown in figures 3-12 and 3-13. Once the turf was placed on top of the glue and secured in the milling and concrete ramp, ballast sand can be added, if desired.

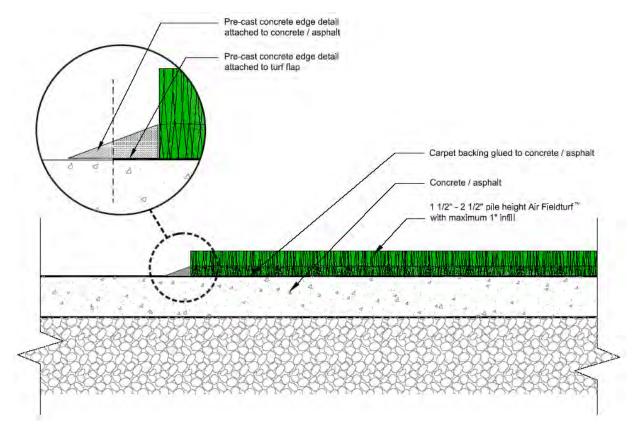
FIGURE 3-11. PRECAST CONCRETE EDGE DETAIL FOR INSTALLATION ON CONCRETE AND ASPHALT

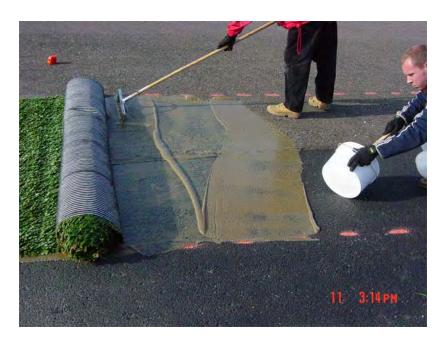
FIGURE 3-12. APPLICATION OF ENVIRONSTICK TWO-PART GLUE ON ASPHALT

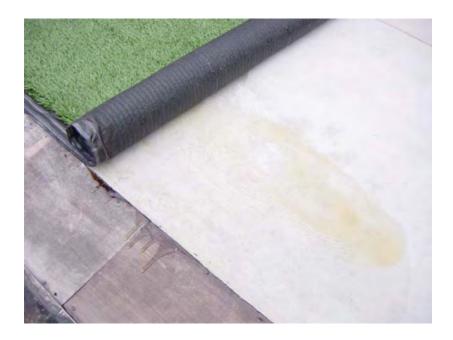
FIGURE 3-13. APPLICATION OF NORDOT 34N ON CONCRETE

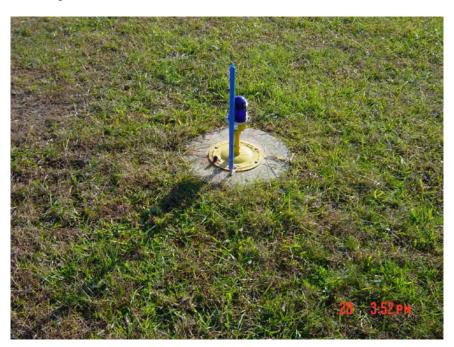
FIGURE 3-14. LIGHT CAN PRIOR TO ARTIFICIAL TURF BOX INSTALLATION

- a. The area around the light can or sign (approximately a 5 by 5 area) was marked to find the limits of the top soil to be removed (figure 3-14).
- b. Using standard sod cutter equipment, the existing grass was excavated to a depth of 1 1/2 inches (figure 3-15).

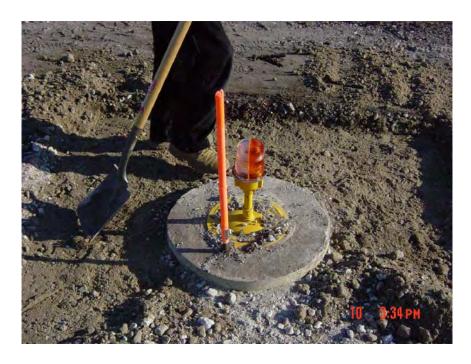
FIGURE 3-15. LIGHT CAN WITH INSTALLATION AREA DUG OUT

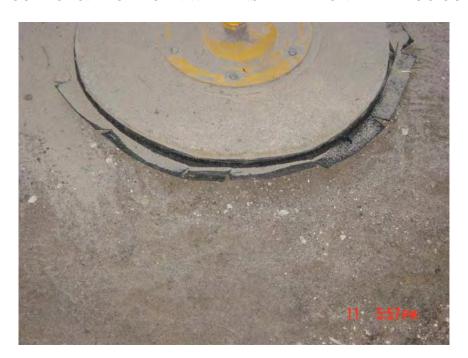
FIGURE 3-16. LIGHT CAN WITH FLEXIBLE L ANGLE INSTALLED

- c. The excavated area was cleaned and smoothed (sand or top soil is sometimes added) prior to placement.
- d. A flexible L angle was attached (figure 3-16) to the light base-mounting fixture. Adhesive was placed on the horizontal edge of the fixture to form a seal (preventing growth from coming through), or the turf was cut around the light base-mounting fixture and affixed with a zip tie (figure 3-17).

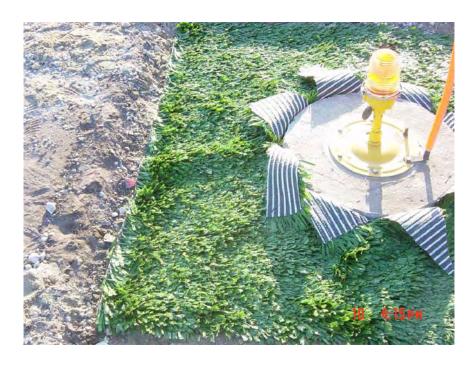
FIGURE 3-17. LIGHT CAN WITH ZIP TIE ATTACHMENT

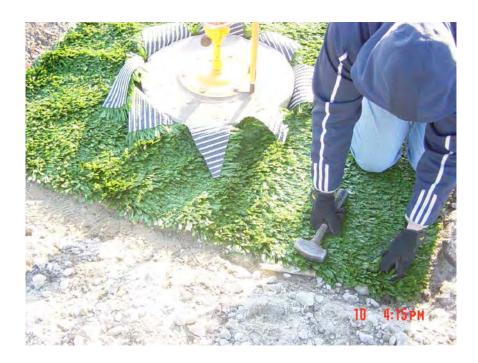
FIGURE 3-18. TURF-PEGGING ARTIFICIAL TURF TO GROUND

- g. Turf pegs were used to fasten the turf into the ground at each corner and evenly along the edges at 12-inch centers (figure 3-18).
- h. After the turf was anchored into the ground, the artificial turf area was filled in with ballast sand (figure 3-19).

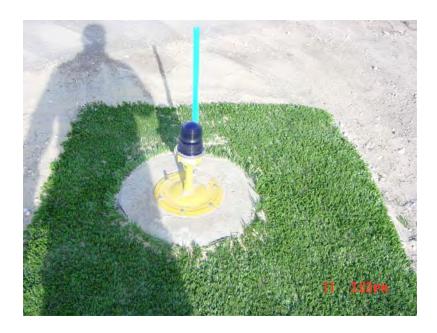
FIGURE 3-19. COMPLETED INSTALLATION AROUND LIGHT CAN

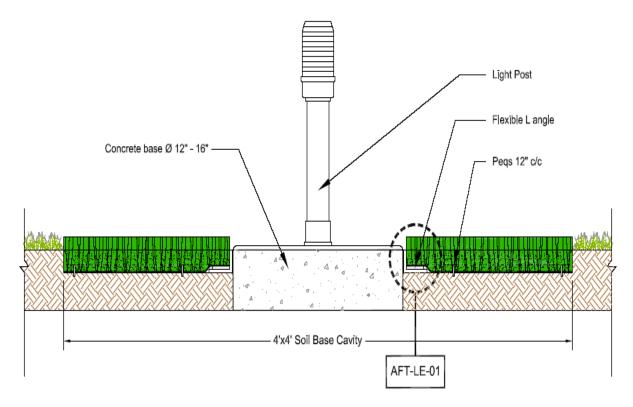
FIGURE 3-20. AIR FIELDTURF CROSS-SECTIONAL VIEW OF THE LIGHT CAN INSTALLATION

Figure 3-20 provides a cross-section view of a typical Air FieldTurf sign or light can installation. Figure 3-21 shows a detailed view of how the artificial turf attaches to the sign or light basemounting fixture.

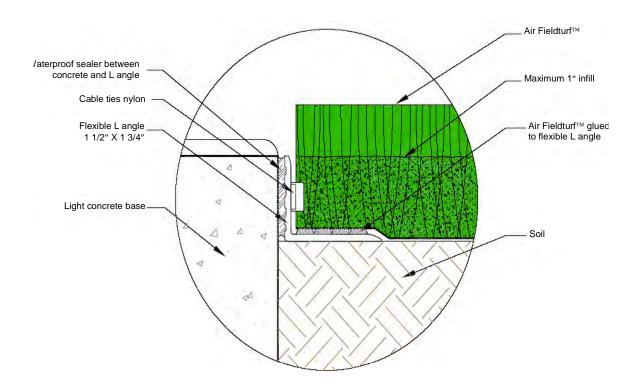
FIGURE 3-21. AIR FIELDTURF CLOSE-UP VIEW OF LIGHT CAN ATTACHMENT

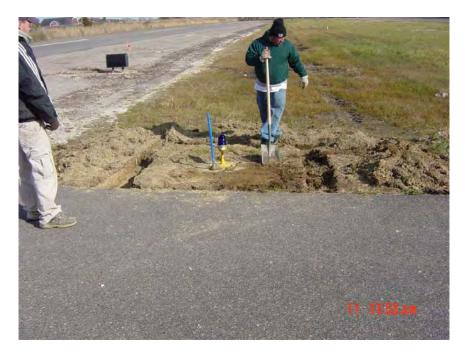
FIGURE 3-22. LIGHT CAN BEING TRENCHED FOR INSTALLATION OF ARTIFICIAL TURF

- a. A trench was excavated to bury the edge of the turf (figure 3-22).
- b. The trench is dug in either a V or U shape with a minimum depth of 18 inches and a minimum width of 12 inches.

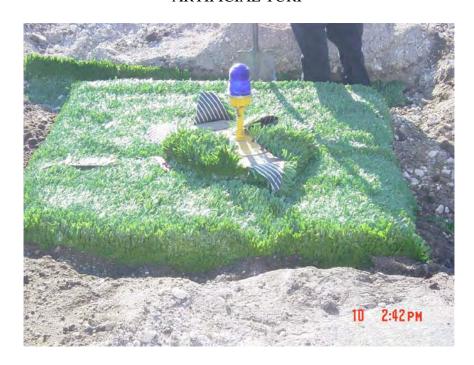
FIGURE 3-23. TRENCHED ARTIFICIAL TURF PLACED AROUND LIGHT CAN

- e. A flexible L angle was attached to the light base-mounting fixture. Adhesive was placed on the horizontal edge of the fixture to form a seal (preventing growth from coming through), as shown in figures 3-23 and 3-24, or the turf is cut around the light base-mounting fixture and glued directly to the top of the light-mounting fixture, as shown in figure 3-25.

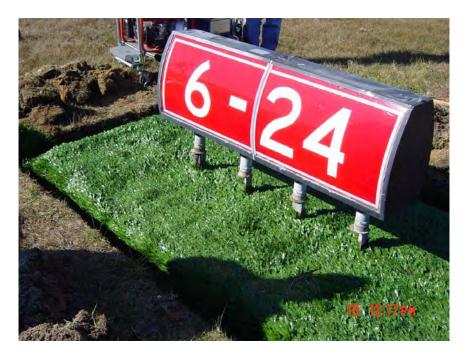
FIGURE 3-24. TRENCHED ARTIFICIAL TURF PLACED AROUND SIGN

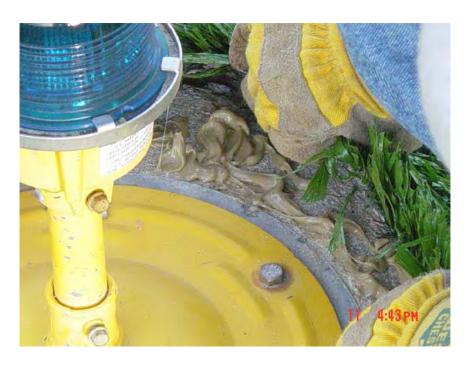
FIGURE 3-25. ARTIFICIAL TURF BEING ATTACHED TO A LIGHT-MOUNTING FIXTURE

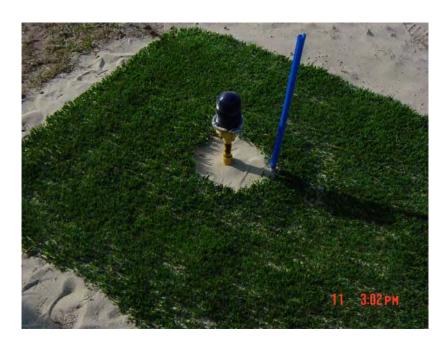
FIGURE 3-26. TRENCHED ARTIFICIAL TURF INSTALLATION AROUND THE LIGHT CAN COMPLETED

- h. The artificial turf was then filled in with ballast sand, as shown in figure 3-26.

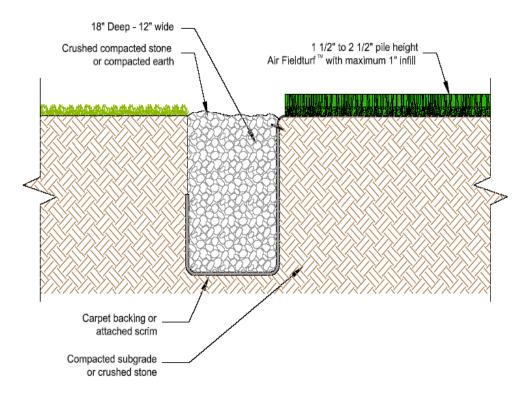
FIGURE 3-27. AIR FIELDTURF CROSS-SECTIONAL VIEW OF A U-SHAPED TRENCH INSTALLATION

Figures 3-27 and 3-28 show a cross-sectional view of the different types of trenching techniques used to bury the artificial turf.

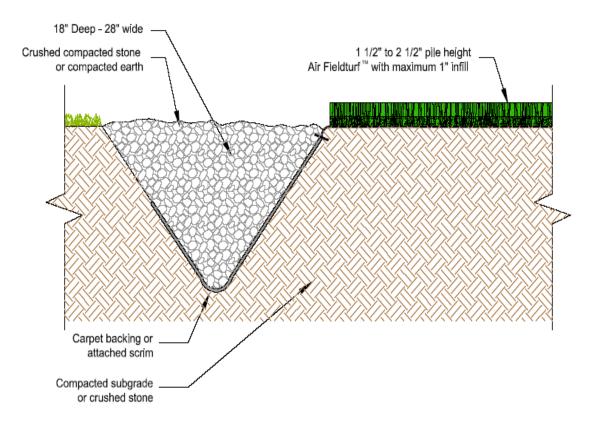
FIGURE 3-28. AIR FIELDTURF CROSS-SECTIONAL VIEW OF A V-SHAPED TRENCH INSTALLATION

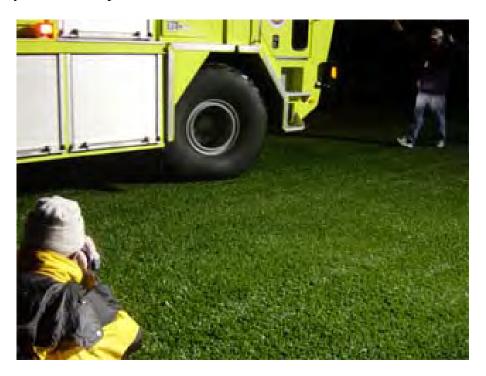
FIGURE 4-1. AN ARFF VEHICLE CONSTANTLY TURNING WHEELS ON ARTIFICIAL TURF SURFACE (BOS)

To determine if the artificial turf would shift or be dislodged by a turning vehicle, an ARFF vehicle, shown in figure 4-1, was slowly driven on the turf surface while constantly turning. No damage was noted, and the same ARFF vehicle, shown in figure 4-2, was directed to gain speed on an adjacent taxiway then veer onto the turf surface and veer off. No movement of the turf or displacement of the anchoring system was noted. No problems with traction or maneuverability were noted by the vehicle operator.

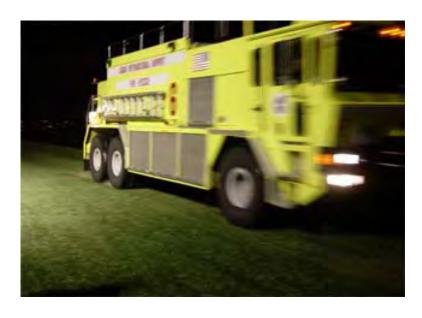
FIGURE 4-2. AN ARFF VEHICLE PERFORMING A HIGH-SPEED PASS (BOS)

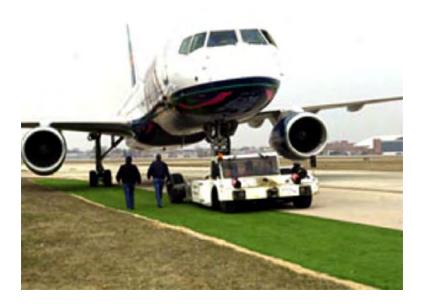
FIGURE 4-3. FULLY FUELED B-757 TAXIING ACROSS ARTIFICIAL TURF SURFACE (BOS)

Another load test that was performed by airport operations staff at MDW was to use the right main gear of a B-757 with full fuel tanks (see figure 4-3) to taxi across the edge of the artificial turf installation. The aircraft was able to taxi across the entire surface without incident. Minimal rutting occurred, but this was easily repaired by using a heavy roller to smooth out the surface.

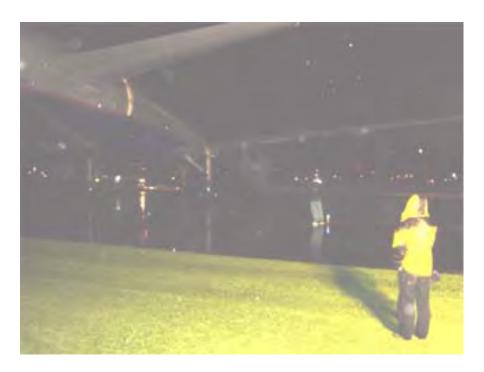
FIGURE 4-4. BOEING 757 PERFORMING JET BLAST TEST ON ARTIFICIAL TURF (BOS)

BOS used a United Airlines B-757, as shown in figure 4-4, to test the artificial turf's resistance to jet blast erosion. Additionally, United Airlines provided a B-777 and a B-747 to perform similar jet blast tests at SFO. The results of the jet blast tests are provided in the following sections.

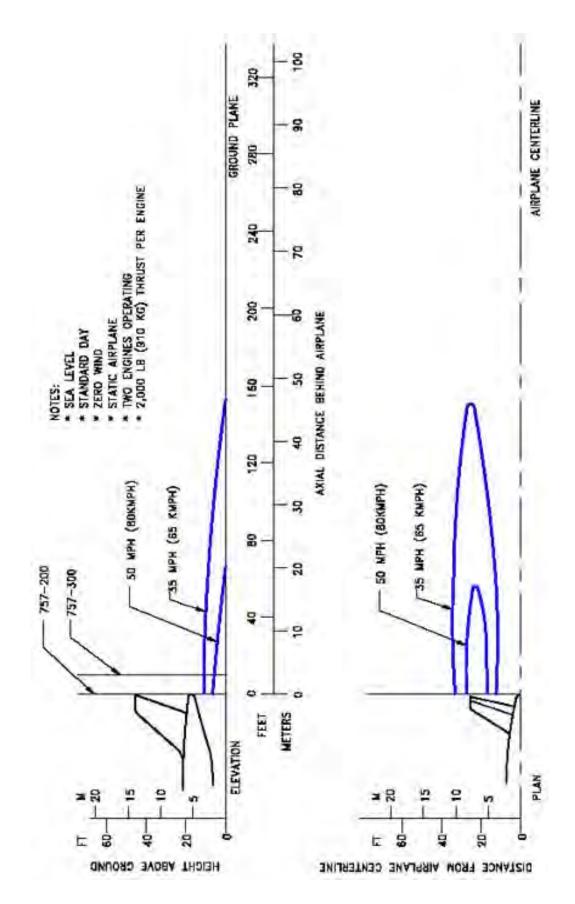
FIGURE 4-5. JET ENGINE EXHAUST VELOCITY FOR A B-757-200 AT IDLE THRUST

For the B-757 tests, the aircraft was placed perpendicular to the runway at two different distances (35 and 45 ft) ahead of the turf. The aircraft was cycled at three different power levels. The first set of tests used just the left engine at idle at distances of 35 and 45 ft with no visible signs of sand migration or damage to the turf surface, then with both engines at idle at 35 and 45 ft with no visible signs of sand migration or damage to the turf surface. The second set of tests used just the left engine at 70% thrust (approximately 88 mph) at 35 and 45 ft, with no visible signs of sand migration or damage to the turf surface, then both engines at 70 percent thrust (approximately 176 mph) at both 35 and 45 ft with no visible signs of sand evacuation or damage to the turf surface. The final sets of tests were conducted under the same procedure using 80 percent thrust (approximately 100 and 200 mph respectively) and still no visible signs of sand migration or damage to the turf surface. The B-757 has a top wind speed of 250 mph at 40 ft behind the aircraft during takeoff (see figures 4-5 and 4-6); however, the tests were not continued because of personnel and aircraft safety.

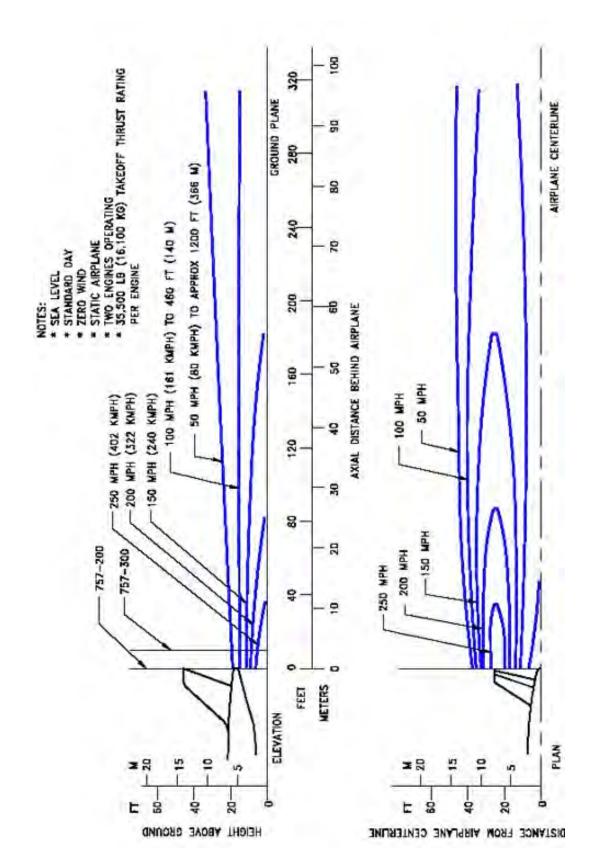
FIGURE 4-6. JET ENGINE EXHAUST VELOCITY FOR A B-757-200 AT TAKEOFF THRUST

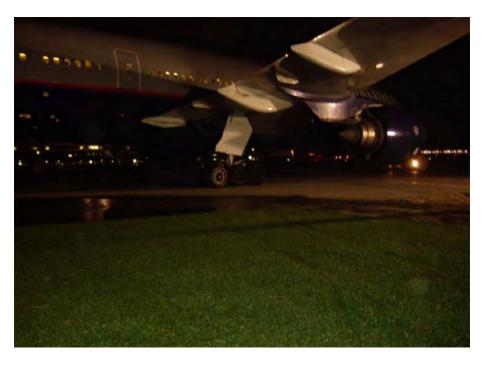
FIGURE 4-7. BOEING 777 JET BLAST TEST, VIEW 1 (SFO)

For the B-777 tests (figure 4-7), the aircraft was positioned on the runway at a 45 degree angle to the turf at two different distances (approximately 35 and 45 feet). The tests were conducted with the left engine (figures 4-8 and 4-9) at idle (19 percent thrust) and then cycled every 30 seconds starting from breakaway (30 percent) thrust upward in 5 percent increments up to 50 percent thrust (50 percent thrust is the safest power setting that the United team would allow). The following lists the approximate wind speeds, in mph, behind the aircraft for 35 ft. According to Boeing's ACAP Manual, the wind speeds behind a B-777 are the same at 35 and 45 feet; therefore, only the 35-foot wind speed tests are shown.

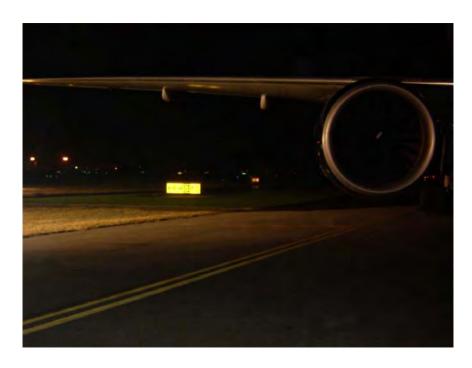
FIGURE 4-8. BOEING 777 JET BLAST TEST, VIEW 2 (SFO)

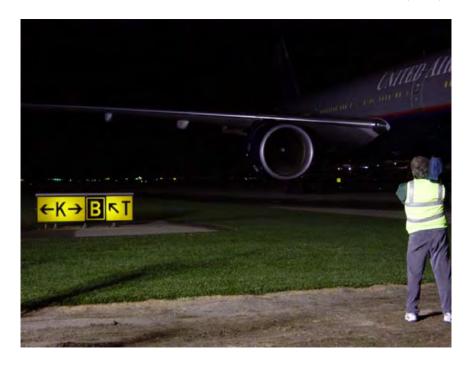
FIGURE 4-9. BOEING 777 TAXIING BY ARTIFICIAL TURF (JET BLAST TEST ACROSS ARTIFICIAL TURF SURFACE) (SFO)

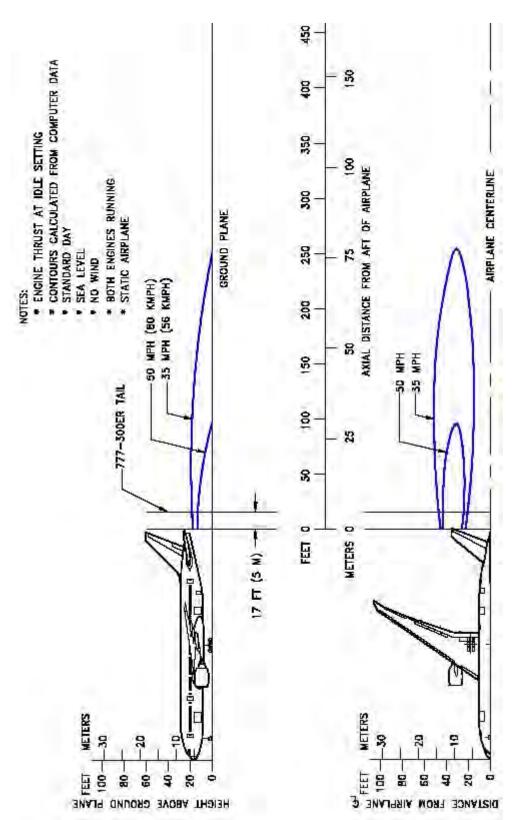
FIGURE 4-10. JET ENGINE EXHAUST VELOCITY FOR A B-777 AT IDLE THRUST

After the static aircraft engine run-ups were completed, the B-777 taxied parallel to the artificial turf three times (each pass getting closer to the turf). There was no visible sand movement or turf displacement. The B-777 has a top wind speed of 200 mph at 50 ft behind the aircraft during takeoff (see figures 4-10, 4-11, and 4-12), but the tests were restricted for safety precautions.

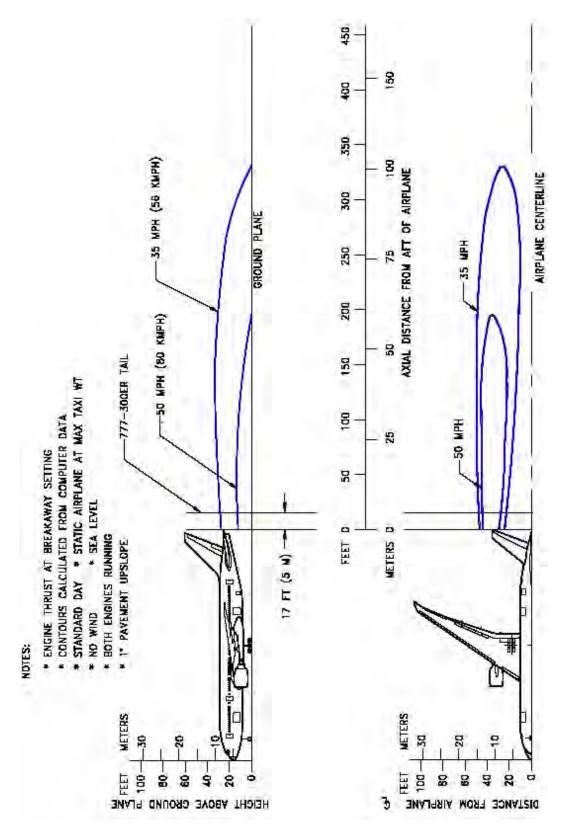
FIGURE 4-11. JET ENGINE EXHAUST VELOCITY FOR A B-777 AT BREAKAWAY THRUST

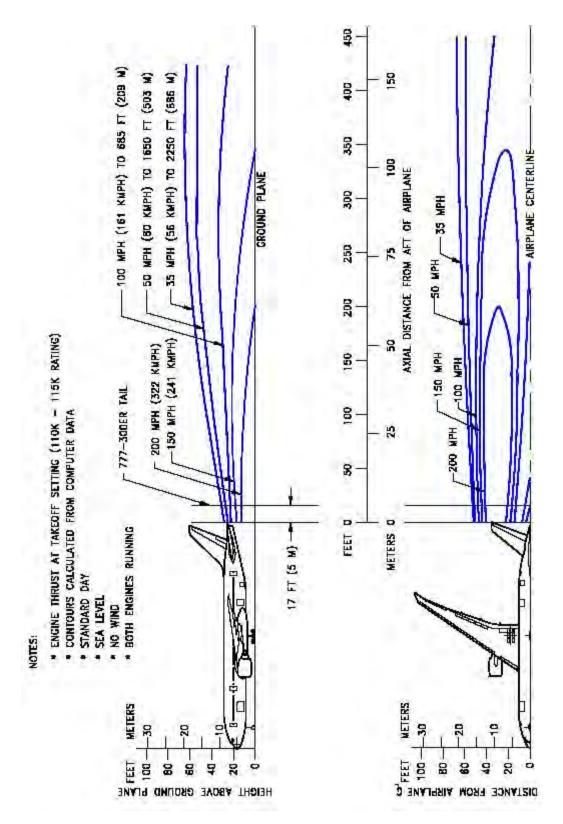
FIGURE 4-12. JET ENGINE EXHAUST VELOCITY FOR A B-777 AT TAKEOFF THRUST

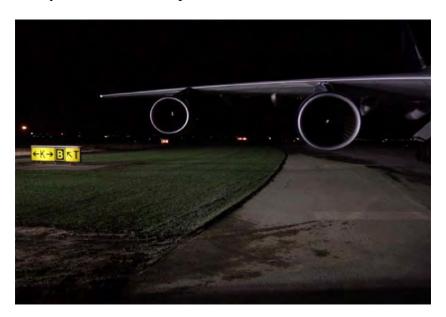
FIGURE 4-13. BOEING 747 JET BLAST TEST (STATIC AIRCRAFT), VIEW 1 (SFO)

For the B-747 tests, the aircraft was positioned on the runway at a 45 degree angle to the turf at two different distances (approximately 35 and 45 feet). The tests were conducted with the number 3 engine (see figures 4-13 and 4-14) at idle (19 percent thrust) and then cycled every 30 seconds starting from breakaway (30 percent) thrust upward in 5 percent increments up to 50 percent thrust (50 percent thrust is the safest power setting that the United team would allow). According to Boeing's ACAP Manual, the wind speeds behind a B-747 are the same at 35 and 45 feet; therefore, only the 35-foot wind speed tests are shown.

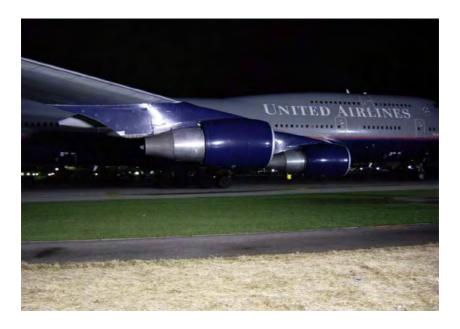
FIGURE 4-14. BOEING 747 JET BLAST TEST (STATIC AIRCRAFT), VIEW 2 (SFO)

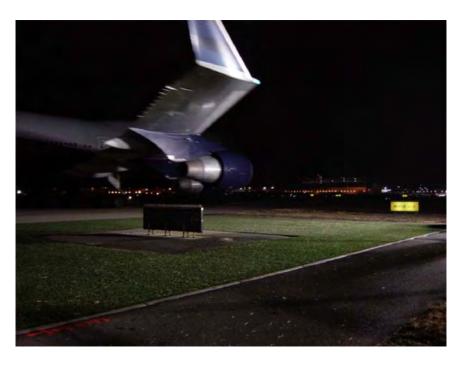
FIGURE 4-15. BOEING 747 TAXIING BY ARTIFICIAL TURF (JET BLAST TEST ACROSS ARTIFICIAL TURF SURFACE) (SFO)

After the static aircraft engine run-ups were completed, the B-747 also taxied by the artificial turf three times (each pass getting closer to the turf). The entire time the aircraft taxied past the installation the outboard engine was directly over the artificial turf (see figures 4-15 and 4-16). The B-747 has a top wind speed of 250 mph at 25 ft behind the aircraft during takeoff (see figures 4-17, 4-18, and 4-19).

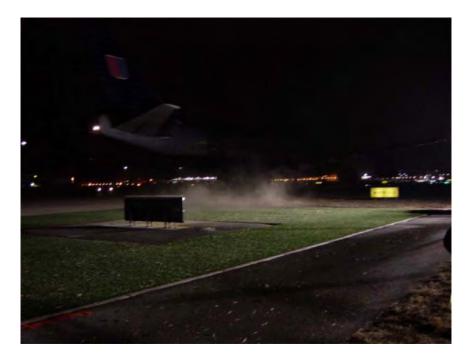
FIGURE 4-16. BOEING 747 TAXIING FROM ARTIFICIAL TURF TO NATURAL GRASS (JET BLAST TEST ACROSS ARTIFICIAL TURF SURFACE) (SFO)

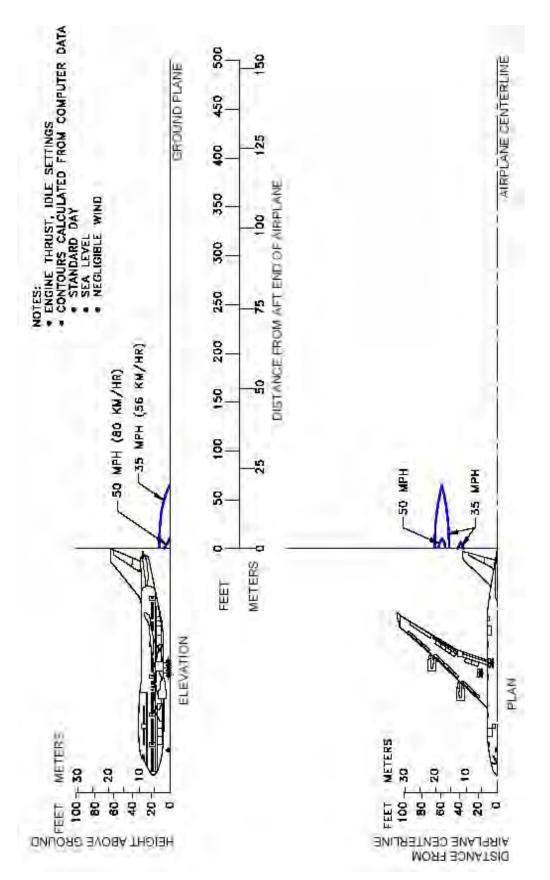
FIGURE 4-17. JET ENGINE EXHAUST VELOCITY FOR A B-747 AT IDLE THRUST

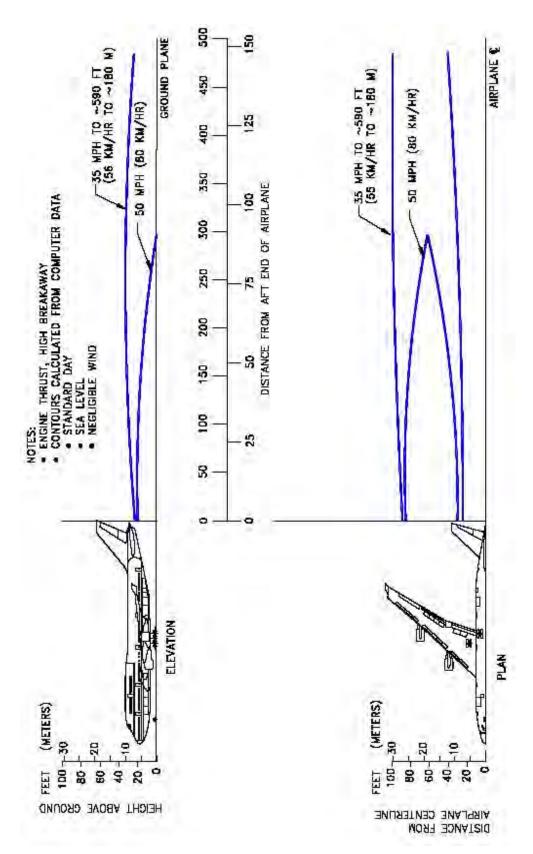
FIGURE 4-18. JET ENGINE EXHAUST VELOCITY FOR A B-747 AT BREAKAWAY THRUST

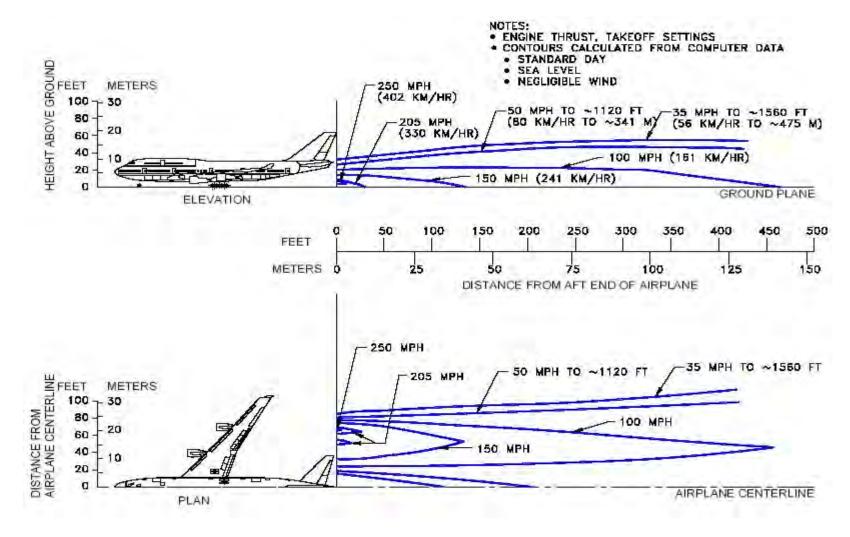
FIGURE 4-19. JET ENGINE EXHAUST VELOCITY FOR A B-747 AT TAKEOFF THRUST

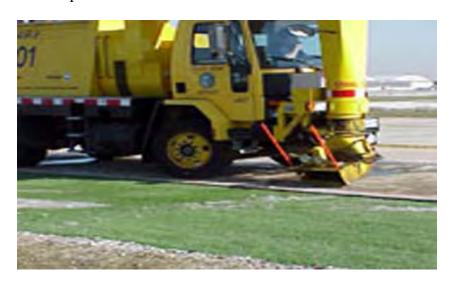
FIGURE 4-20. CONCENTRATED AIR BLOWER USED ON EDGE ATTACHMENT OF ARTIFICIAL TURF (BOS)

Concentrated air blowers are used to clean debris from runways and taxiways. One artificial turf installation was tested using a concentrated air blower with a multiangle nozzle, as shown in figure 4-20. The artificial turf was tested at multiple angles with different wind velocities; no sand or artificial turf displacement was seen.

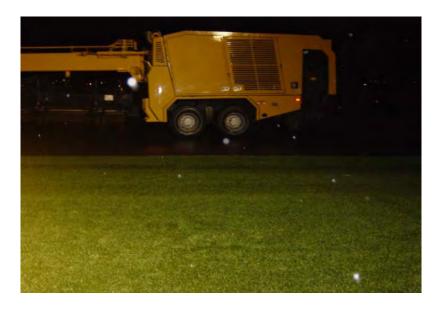
FIGURE 4-21. VAMMAS SNOW BLOWER TEST OF ARTIFICIAL TURF (BOS)

The artificial turf installation was jet blast tested using a VAMMAS (see figure 4-21) snow blowing machine with a multiangle nozzle at BOS. The artificial turf was tested with the snow blowing machine positioned at multiple angles with different power settings; no sand or artificial turf displacement was seen.

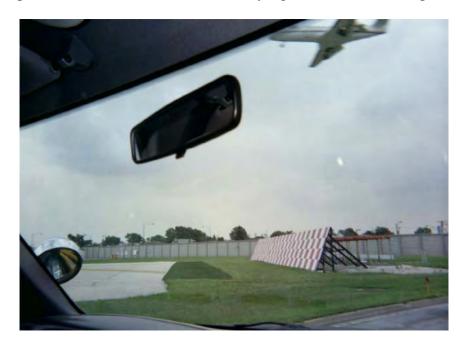
FIGURE 4-22. ARTIFICIAL TURF INSTALLED AT MDW BLAST PAD LOCATION

To ensure that the artificial turf would not become dislodged or cause FOD damage with everyday airport usage, a test strip was installed at the blast area of a runway at MDW (see figure 4-22). The strip was successful and did not show any signs of movement or uplift.
