## **DOT/FAA/AR-06/23**

# **Airside Applications for Artificial Turf**

June 2006

Final Report

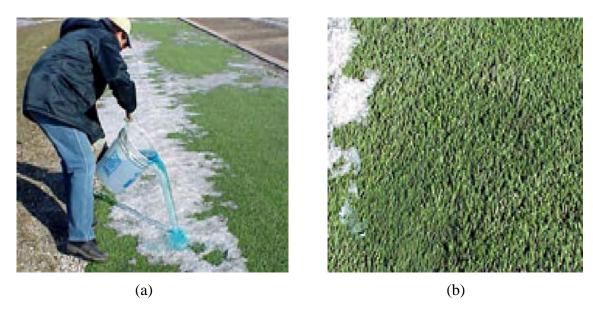
FIGURE 4-23. SATURATING THE ARTIFICIAL TURF WITH POTASSIUM ACETATE (MDW)

A deicing fluid durability test on the artificial turf product was performed during the winter operations and snow clean up at MDW, as shown in figure 4-23. Snow was purposely piled on the surface and potassium acetate was poured on the snow to accelerate the melting process. No adverse effects to the artificial turf were witnessed, and the snow continued to melt at an accelerated rate without adding more deicing fluid.

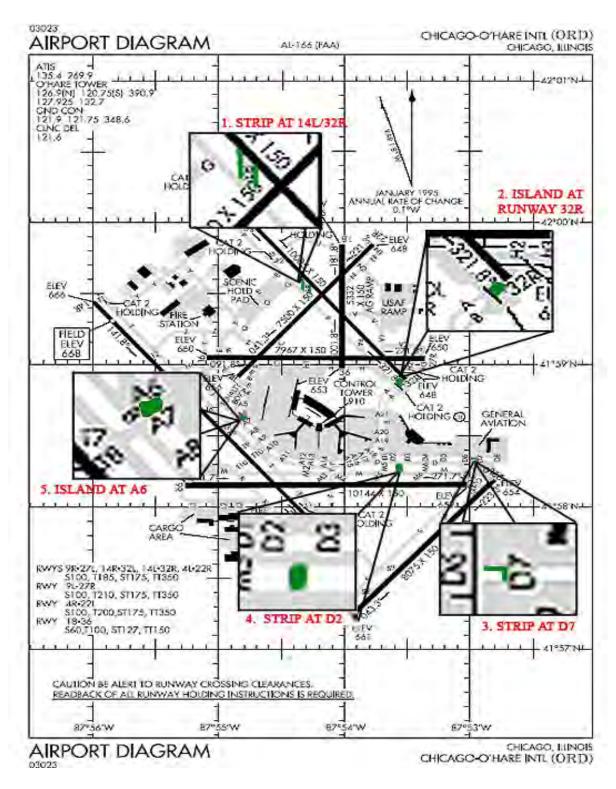
FIGURE A-1. O'HARE INTERNATIONAL AIRPORT INSTALLATION SITES

At ORD, an island located off taxiway M5 (near airline docking stations) had been painted green to provide some visual distinction of where a taxiway ended and a runway began, (see figure 2-26 and appendix A, figure A-1). However, after 1 or 2 years of use, the paint had faded and started to chip and peel. The airport found that it was too costly to shutdown and repaint the area every year, so an artificial turf was installed to replace the painted area.

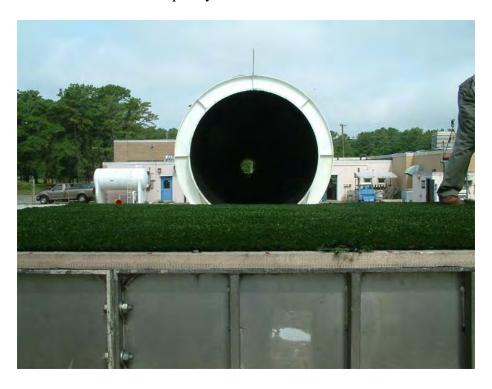
FIGURE C-1. TEST PLOT INSTALLED AT THE FAA WILLIAM J. HUGHES TECHNICAL CENTER WIND TUNNEL

At the Federal Aviation Administration (FAA) William J. Hughes Technical Center wind tunnel tests (figure C-1) were performed on the various fiber lengths of artificial turf to determine how high winds and jet blasts might affect the ballast sand infill. These tests were meant to simulate the effects over 1 month of jet blast and high winds to determine how often the ballast sand must be replaced during normal operations. It should be noted that the testing being performed was to quantify the artificial turf and not to qualify the turf.

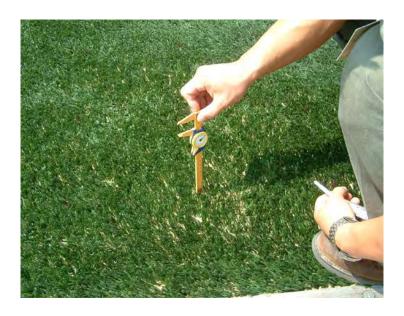
FIGURE C-3. MEASURING SAND MOVEMENT

The artificial turf was installed on the test plot with a header system and the standard ballast sand infill. Measurement points of 1 by 1 ft were marked into the turf surface to determine sand depths (figure C-3). A total of 12 rows and 11 columns were marked. Figure C-4 is a cross-sectional view of the AvTurf installation used in the wind tunnel tests.

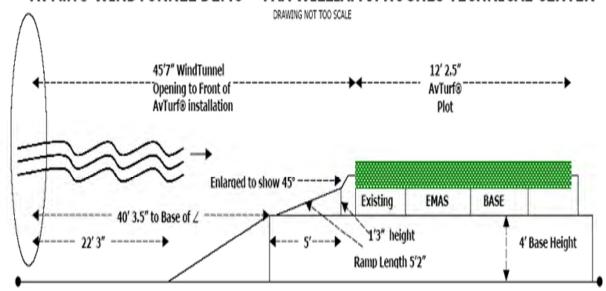
FIGURE C-4. AVTURE ENGINEERING DRAWING FROM WIND TUNNEL TEST

# AvTurf® WINDTUNNEL DEMO - FAA WILLIAM J. HUGHES TECHNICAL CENTER

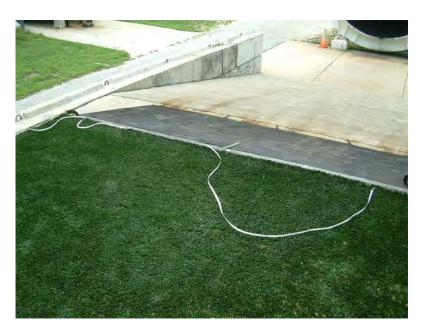
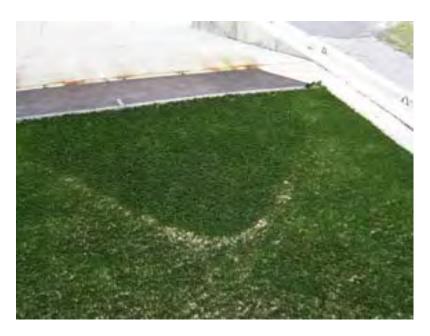
FIGURE C-13. MEASURING CONE OUTLINE

FIGURE C-14. CONE SHAPE FROM MIGRATION OF SAND

It was determined that the AvTurf artificial turf product would experience heavy sand migration or removal (figures C-13 and C-14) from the artificial turf fibers between the fourth and fifth month at an airport that experienced aircraft traffic similar to LGA. It was noted that the artificial turf resonated up and down with no ballast sand. A possible explanation for the evacuation of the ballast sand is that the honeycomb fiber pattern is too wide and does not adequately trap the ballast sand.

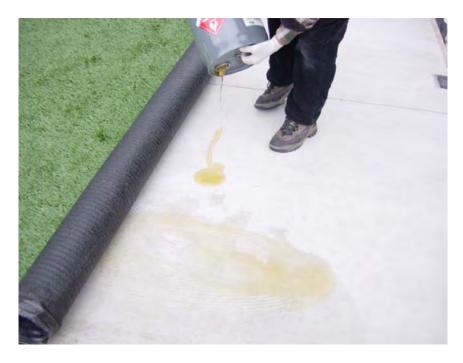
FIGURE C-39. APPLICATION OF ARTIFICIAL TURF TO CONCRETE

To test the glued concrete application for the artificial turf, a 12- by 12-ft concrete slab 4 inches thick was poured on top of the existing test pad (figure C-39). Once the concrete was dried, the surface was acid washed with an industrial-grade citric acid. After the acid wash was complete, the concrete pad was scored with two 2-inch-deep lines across the test pad. The artificial turf that was glued to the concrete did not have any sand infill; the purpose of the wind tunnel test was to check the ability of the glue to hold the artificial turf in place during high wind speeds. The glued artificial turf application had two different header systems along the front edge of the test pad; each header was 6 ft wide, dividing the pad in the half. On the left side of the pad, a quick-drying concrete header was set up (figure C-40). On the right side of the pad, a flexible rubber header was attached to the turf (figure C-41).

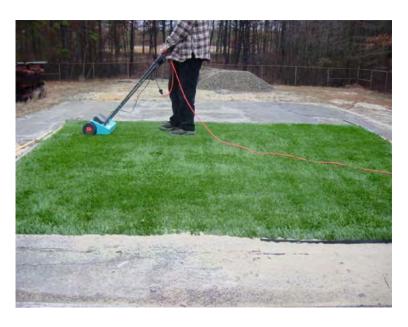
FIGURE C-42. THE 2.0-INCH FIBER TEST PLOT

A 16-cycle test was conducted to experiment with the ballast sand infill for the concrete surface glued application (figure C-42). The purpose of the test was to determine if the ballast sand would remain in the turf glued to the surface, as opposed to the turf installation being even with the ground.

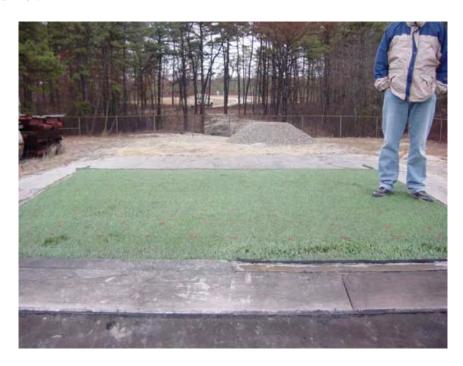
FIGURE C-43. TEST 7—2.0-INCH FIBER TEST PLOT AFTER TESTS

Measurement points of 1 by 1 ft were marked into the turf surface to determine sand depths; a total of 3 rows and 11 columns were marked (figures C-43 and C-44). Figures C-45 and C-46 show a cross-sectional view of the 2.0-inch fiber test plot with the two different headers installed at the wind tunnel.

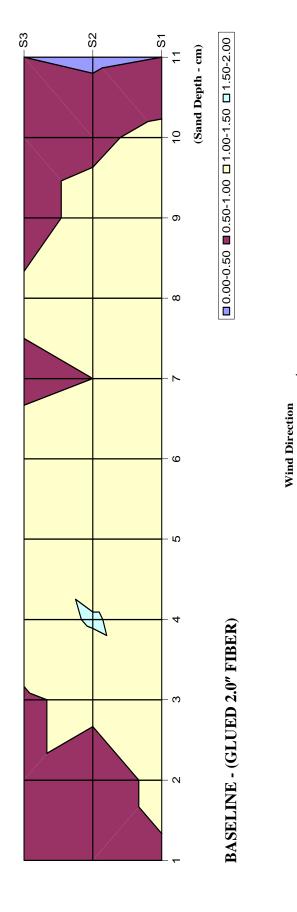
FIGURE C-47. TEST 7—BASELINE LAYOUT

- Baseline (figure C-47). The baseline depth of the ballast sand measured from 0.75 to 1.30 inches.
- Run 1—Eight cycles at 40 ft (figure C-48). Once the test was completed, measurements were taken at the plot points. The depth of the ballast sand measured from 0.40 to 1.35 inches. Very minimal sand movement was noted. It was determined that the glued 2.0-inch fiber was successful for eight cycles at 45 ft.

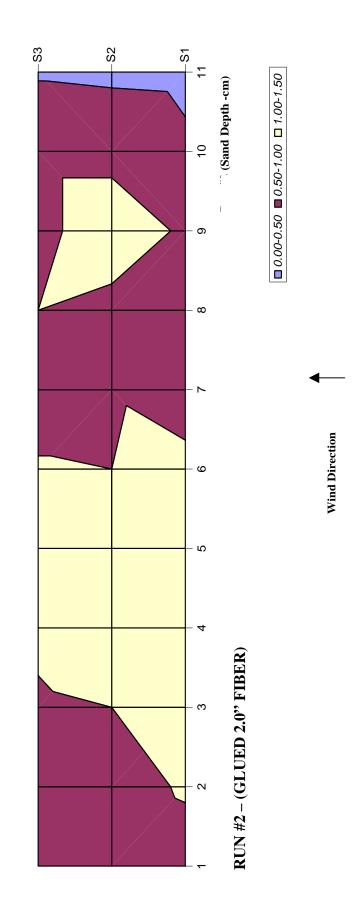
FIGURE C-49. TEST 7—RUN 2, EIGHT CYCLCES AT 40 FEET

- Run 2—Eight cycles at 40 ft (figure C-49). A second eight-cycle test was performed at 40 ft to determine if the 2.0-inch glued artificial turf fibers would no longer retain ballast sand. No sand was added to the turf. Once the test was completed, measurements were taken at the plot points. The depth of the ballast sand measured from 0.50 to 1.25 inches. Very minimal sand movement was noted. It was determined that the 2.0-inch fiber was successful for the second eight-cycle test at 40 ft.

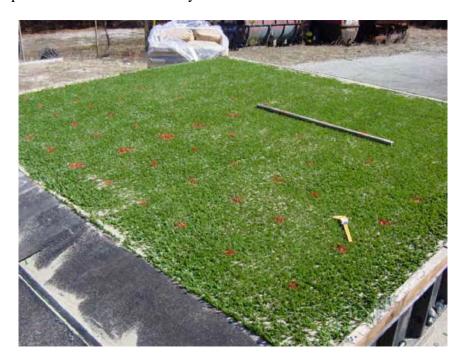
FIGURE C-50. THE 1.5-INCH FIBER TEST PLOT

The original 1.5-inch fiber test plot installation only covered half the test pad and was tested at 75 ft from the runway (figure C-50). A test cycle was conducted with the installation covering the entire test plot at 40 ft from the runway.

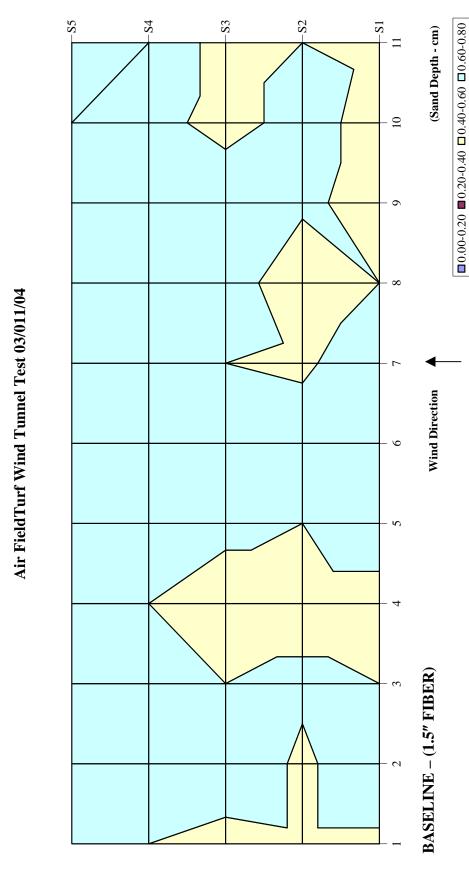
FIGURE C-51. TEST 8—BASELINE LAYOUT

- Baseline (figure C-51). The baseline depth of the ballast sand measured from 0.40 to 0.80 inch.
- Run 1—Four cycles at 40 ft (figure C-52). The test was conducted at the 40-ft profile. During the course of the testing, it was noted that sand was being significantly removed from the artificial turf. After the fourth cycle was completed, the testing was stopped to conduct a visual inspection of the sand evacuation. It was determined that on the right side of the centerline, there was no sand remaining in a five-column space. The left side of the centerline experienced minimal sand movement. The depth of the ballast sand on the left side of the centerline measured from 0.50 to 0.80 inch (figures C-53 and C-54).

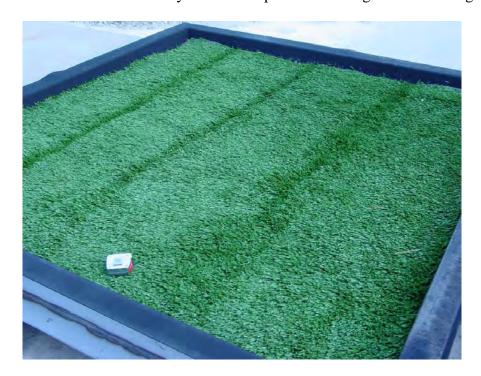
FIGURE D-2. LARGE 2D PAN SAMPLE

The final demonstration was conducted in the larger pan, as shown in figure D-2. The demonstration was conducted to determine if there is any change in the condition of the burnt material when AFFF is applied to the burning material. Twenty gallons of fuel was evenly poured onto the entire sample. The fuel was then ignited using the propane torch. For this evaluation, the fire was allowed to fully involve the pan before using AFFF to extinguish the fire.

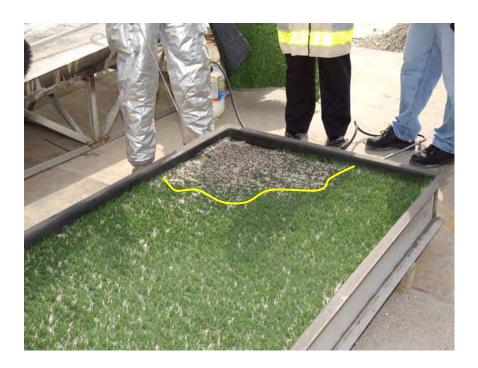
FIGURE D-3. BURNT AREA (OUTLINED IN YELLOW) FROM PROPANE TORCH

The objective of this demonstration was to record the degree of difficulty in igniting the artificial turf itself. Several attempts were made to ignite the artificial turf using a propane torch. When the torch flame came in contact with the artificial turf, it would melt away under the torch. The material would not support combustion on it own, as shown in figure D-3. The air temperature for the day was 48°F with 11-mph winds. Immediately after the torch was removed from the surface of the material the temperature was recorded at 300°F and dropped to 58°F within 3 minutes.

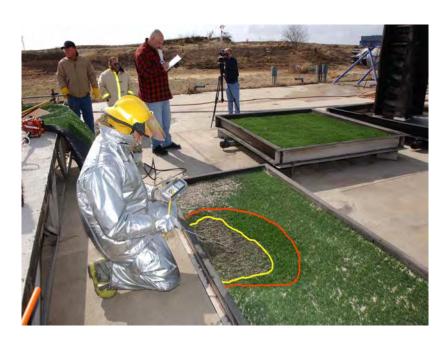
FIGURE D-4. FUEL-SOAKED (OUTLINED IN RED) AND BURNT AREAS (OUTLINED IN YELLOW)

For this demonstration, 3 gallons of fuel was poured into the pan. The fuel-soaked area measured 46 by 210 inches. The fuel was then ignited. The fire did not spread throughout the entire fuel-soaked area. The area burnt was 35 by 17 inches. Both an infrared pyrometer and a thermocouple probe were used to record the temperature of the fire area. Both units recorded a temperature of 330°F with a rapid decline. In the areas where the material was able to completely burn and self-extinguish, the remaining material was a powdery dust, as shown in figure D-4.

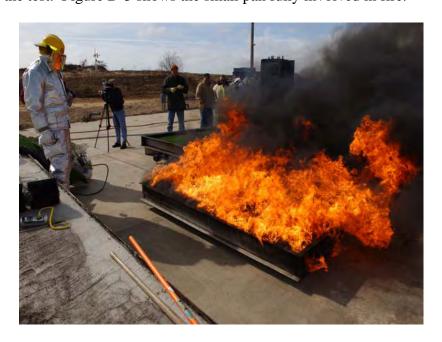
FIGURE D-5. SMALL PAN FIRE—10 GALLONS OF JP-8

The third demonstration again used an installation in the smaller pan. Ten gallons of fuel was evenly poured onto the entire sample. The fuel was then ignited using the propane torch. For this evaluation, the fire was allowed to self-extinguish. The fire burned for 12 minutes and 30 seconds before the demonstration coordinator determined that the fire had subsided enough to call the end of the test. Figure D-5 shows the small pan fully involved in fire.

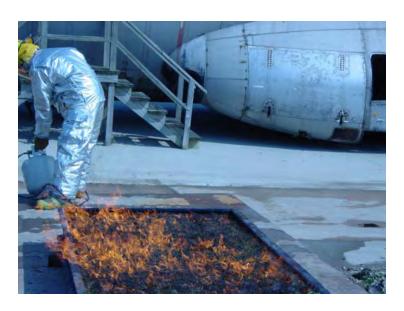
FIGURE D-6. NATURAL GRASS FIRE—10 GALLONS OF JP-8

In comparison, when 10 gallons of JP-8 was allowed to burn freely on a bed of water, it took 5 minutes to completely burn off the fuel. This increase in time to burn off the fuel in the artificial turf test bed was determined to be caused by the slower vaporization of the fuel from within the fuel-soaked ballast material. When 10 gallons of fuel was applied to natural grass test beds, as shown in figure D-6, the fire had little intensity and remained low to the ground. The natural grass burned for 10 minutes before the test was called. Within 5 minutes of each natural grass test, the fire was only visible at the seams of the sod used to create the test bed, as shown in figure D-7. Figures D-8 and D-9 show the temperature traces and peak temperatures of the sod and AvTurf demonstrations.

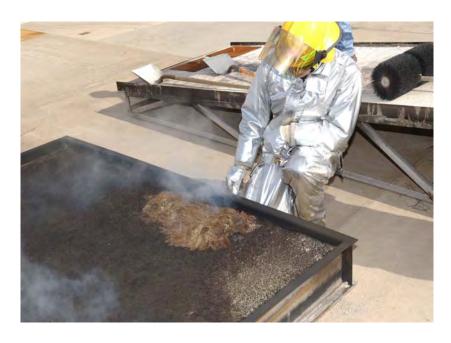
FIGURE D-10. POSTFIRE INSPECTION

The primary objective of this demonstration was to determine if the condition of the burnt material would hinder the evacuation of passengers across an area with artificial turf installed in a postcrash fire event. The infrared pyrometer recorded temperatures of up to  $1000^{\circ}$ F during the demonstration. As in the earlier demonstration, in the areas where the material was able to completely burn and self-extinguish, the remaining material was a powdery dust. This is evident in figure D-10 of the postfire inspection. With the exception of where the edges of the material came into contact with the stainless steel pan, the backing material stayed intact with no damage. In most areas, there was still a small amount of artificial turf fiber that was buried in the ballast material that remained intact. The exposed portion of the fiber was melted away but the buried material remained.

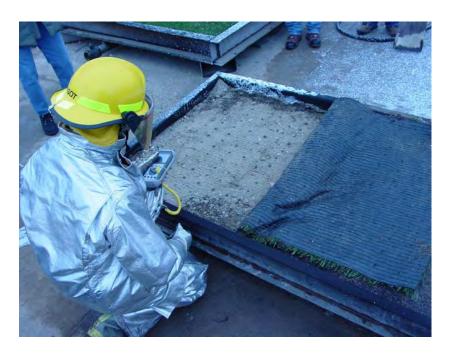
FIGURE D-11. POSTFIRE INSPECTION OF TURF AND BASE MATERIAL

Also of interest in this demonstration was the lack of fuels that permeated through the artificial turf and its backing material onto the base material. As shown in figure D-11, the artificial turf backing material had a grid of perforation holes in it for drainage. The dots on the base material are the areas where fuel seeped through the backing material. These wet spots were only on the surface of the base material and did not saturate the area.

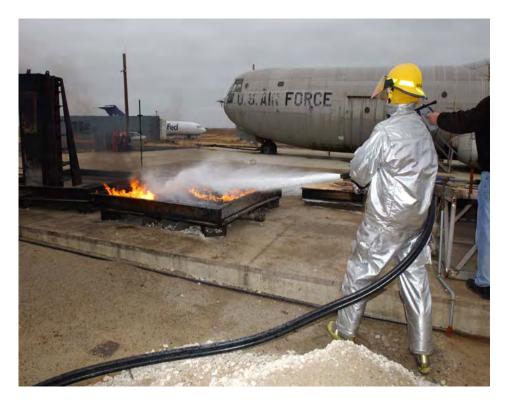
FIGURE D-12. APPLYING AFFF

The final demonstration was conducted to determine if there is any change in the condition of the burnt material when AFFF is applied. For this demonstration, 20 gallons of fuel was evenly poured onto the entire sample installed in the large pan. The fuel was then ignited using a propane torch. For this evaluation, the fire was allowed to become fully involved in the pan before using AFFF to extinguish the fire, as shown in figure D-12.

The fire was extinguished very rapidly by the AFFF agent with only a small amount of agent discharged. The peak temperature recorded with the infrared pyrometer during the burn was 1000°F and rapidly dropped to 130°F upon agent application.

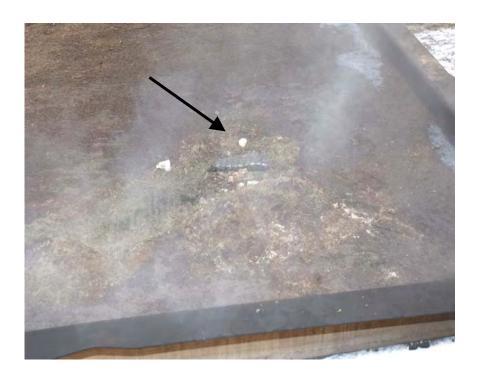
FIGURE D-13. DAMAGED BACKING MATERIAL

The condition of the burnt artificial turf was similar to the previous burns with the burnt artificial turf turning to a powdery substance. There were some portions of the material that did burn enough to damage the backing material of the artificial turf, as shown in figure D-13. A firefighter in protective gear walked across the test bed to determine what it would be like to evacuate across the burnt material. Even in the areas where the backing material was damaged, the traction was good. When the integrity of the artificial turf and backing material was compromised, the base material was exposed and gave a solid surface for evacuation.

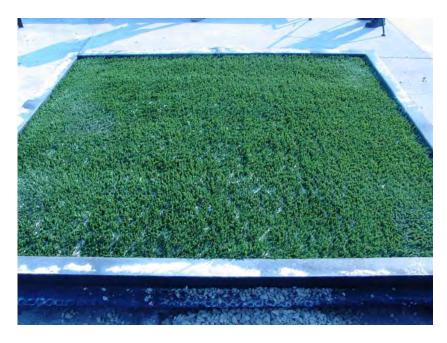
FIGURE D-14. LARGE 2D PAN SAMPLE

The third demonstration was a non-permeable-backed sample installed in the large pan, as shown in figure D-14. Twenty gallons of fuel was evenly poured onto the entire sample, then ignited using a propane torch. For this evaluation, the fire was allowed to free-burn for a period of time before AFFF was applied.

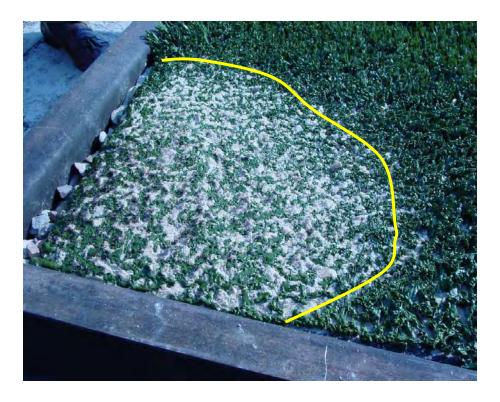
FIGURE D-15. BURNT AREA (OUTLINED IN YELLOW) FROM PROPANE TORCH

The objective was to record the degree of difficulty in igniting the artificial turf itself. Several attempts were made to ignite the artificial turf using a propane torch. The air temperature for the day was 69°F with 11-mph winds. When the torch flame came in contact with the artificial turf, it melted away under the torch. The artificial turf did not support combustion on its own, as

shown in figure D-15. Immediately after the torch was removed from the surface of the artificial turf the temperature was recorded at 200°F and dropped to 115°F 30 seconds later.

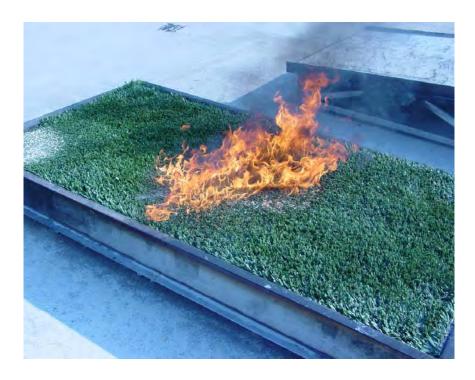
FIGURE D-16. INITIAL FIRE ON FUEL-SOAKED AREA

For this demonstration, 3 gallons of fuel was poured into the pan, then ignited. The fire did not spread throughout the entire fuel-soaked area. An infrared pyrometer was used to record the temperature of the fire area, with the initial temperature being 625°F, then peaking at 768°F, and a final recorded temperature of 525°F 8 minutes into the demonstration. There was more fire spread with this demonstration than in a similar demonstration run with a different artificial turf. This was attributed to the more permeable backing material and the looser crushed stone base material, which allowed for more propagation of the fuel and increased vaporization. Figure D-16 shows the fire in the initial fuel-soaked area. Figure D-17 shows the spread of the fuel once the artificial turf was removed from the base of crushed stone. In the areas where the artificial turf was able to completely burn and self-extinguish, only a powdery dust remained, as shown in figure D-18.

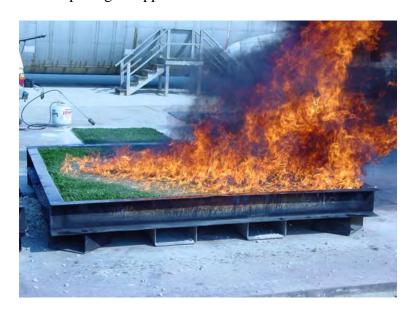
FIGURE D-19. LARGE PAN FIRE—20 GALLONS OF JP-8

Demonstration 3 used an installation in the larger, 8- by 8-ft pan to determine if there was any change in the condition of the burnt material when AFFF was applied. For this demonstration, 20 gallons of fuel was evenly poured onto the entire sample installed in the large pan and ignited with a propane torch. For this demonstration, the fire was allowed to free-burn for approximately 4 minutes to fully involve the sample, as shown in figure D-19. At that point, AFFF was applied to extinguish the fire and evaluate the residual material. The fire was extinguished very rapidly by the AFFF agent with only a small amount of agent discharged. The peak temperature recorded with the infrared pyrometer during the burn was 1350°F, which rapidly dropped to 200°F upon agent application.

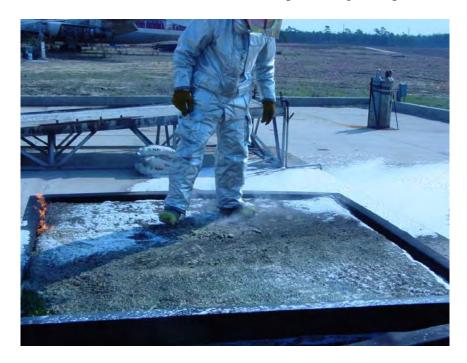
FIGURE D-20. CONDITION AFTER FIRE IS EXTINGUISHED

Figure D-20 shows the condition of the material after extinguishment. The base material shown in figure D-21 had no fuel contamination due to this sample having a nonpermeable backing.

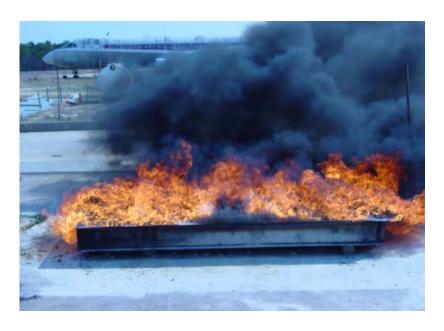
FIGURE D-22. INITIAL PHASE OF FIRE

Demonstrations 4 and 5 were conducted in the smaller pan to evaluate the effects of the permeable and nonpermeable backing of the samples. Demonstration 4 used a permeable-backed material, and demonstration 5 used a non-permeable-backed material. Ten gallons of fuel was evenly poured onto the entire sample, and then ignited with a propane torch. In demonstration 4, the fire was more intense initially with a long lasting low-level, sustained fire as the fuels burned off, as shown in figures D-22 and D-23.

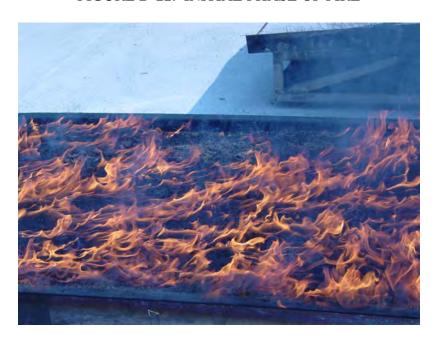
FIGURE D-23. LOW-LEVEL, SUSTAINED FIRE

The low-level, sustained fire of demonstration 4 began at the 10-minute mark of the demonstration and continued until the test was called at 45 minutes. For demonstration 5, the test was called at the 9-minute mark when the fire reached the same low-level intensity as in demonstration 4 with limited fire area involved. This was a subjective decision made by the demonstration coordinator. The recorded peak temperature for demonstration 4 was 1220°F, while demonstration 5 achieved a peak temperature of 1050°F. While these peak temperatures were very close, the fire in demonstration 5 died down to the low-level, sustained fire much quicker than in demonstration 4. This can be seen in the data traces shown in figure D-24.

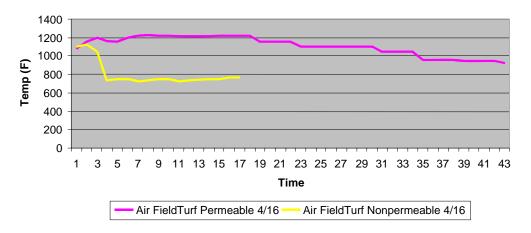
FIGURE D-24. DATA TRACES OF PERMEABLE- AND NON-PERMEABLE-BACKED SAMPLES

# Permeable vs. Nonpermeable

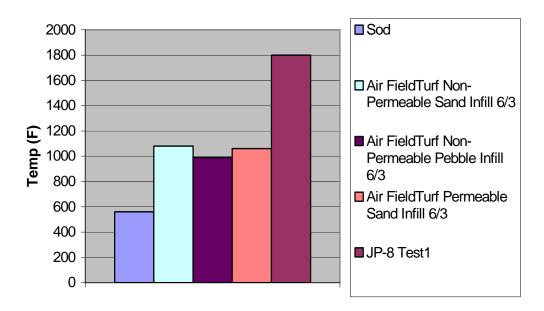
FIGURE D-25. PEAK RECORDED TEMPERATURES

Demonstrations 6 through 9 were conducted to compare combinations of sand versus pebble infill with permeable- and non-permeable-backed material. These demonstrations were also conducted in the smaller pan using 10 gallons of JP-8 fuel. In demonstrations 6, 8, and 9, the duration of the demonstration lasted 28 minutes at which time the evaluation was called by the demonstration coordinator. These three burns had very similar characteristics. The peak recorded temperatures for these burns were between 1000° and 1100°F as shown in chart in figure D-25.

# **Peak Temperatures**

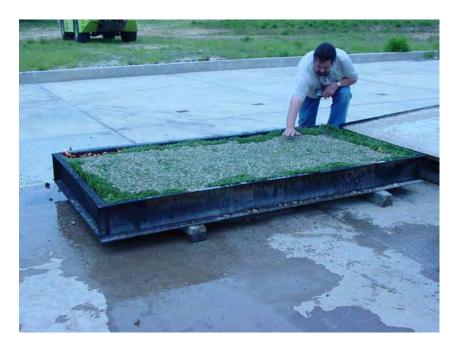
FIGURE D-26. DAMAGE TO MATERIAL AFTER A SHORT BURN (1:30)

Demonstration 7 appeared to be the best combination of infill and permeability. In this demonstration, the fire self-extinguished in 1 minute and 30 seconds. As could be expected, there was also much less damage to the material than in the other three in this group. Figures D-26 and D-27 show the extent of the damage to the material between the burn that lasted 1 minute and 30 seconds and the ones that were called at 28 minutes.

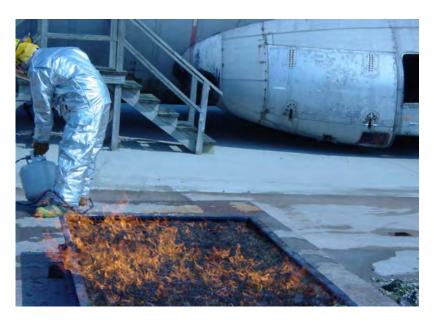
FIGURE D-28. NATURAL GRASS FIRE—10 GALLONS OF JP-8

For comparative purposes, 10 gallons of fuel was applied to natural grass test beds, as shown in figure D-28. The fire had little intensity and remained low to the ground. The natural grass burned for 10 minutes before the demonstration was called. Within 5 minutes of each natural grass demonstration, the fire was only visible at the seams of the sod used to create the test bed, as shown in figure D-29. To baseline temperatures and burn durations, 10 gallons of JP-8 was allowed to burn freely on a bed of water, it took 5 minutes and 20 seconds to completely burn off the fuel. The fire reached a maximum recorded temperature of 1800°F. The increase in time to burn off the fuel in the artificial turf test bed was determined to be caused by the slower vaporization of the fuel from within the fuel-soaked ballast material.

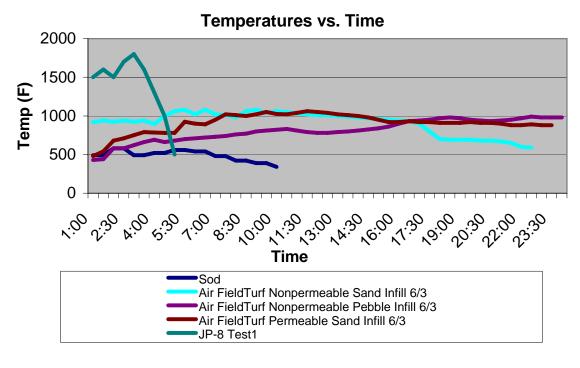
FIGURE D-30. TEMPERATURE TRACES

Figure D-30 shows the temperature traces over the duration of demonstrations 6 through 9 and the sod baseline. Due to the rapid self-extinguishment of demonstration 7, there was insufficient data to create a trace of that burn.

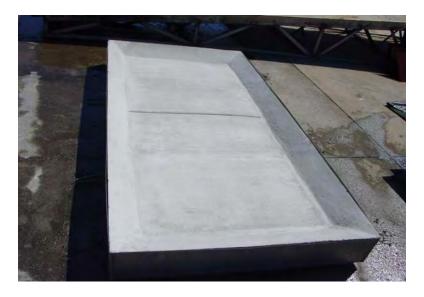
FIGURE D-31. CONCRETE TEST PAD

Seven 4- by 8-ft concrete pads were constructed in metal frames. The pads were constructed to simulate the concrete surfaces the artificial turf would be installed on at an airport. For purposes

of containing the fuel applied to the artificial turf, the edges were flared approximately 4 inches, as shown in figure D-31.

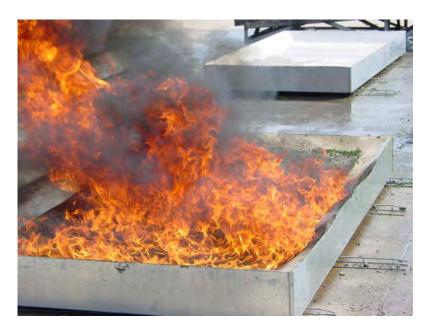
FIGURE D-32. DEMONSTRATION WITH 1-INCH SAND INFILL

Test samples were installed by the manufacturer on the concrete pads. The samples consisted of variations of artificial turf installations both attached and unattached as well as with and without sand infill. All tests had an initial JP-8 fuel application of 3 gallons. The samples with sand infill had an additional 2 gallons applied in one specific area to compensate for fuel absorption into the sand as well as providing an area of pooled fuel to allow for more rapid fire development. Figure D-32 shows the fire intensity with sand infill, while figure D-33 shows the fire intensity without the sand infill.

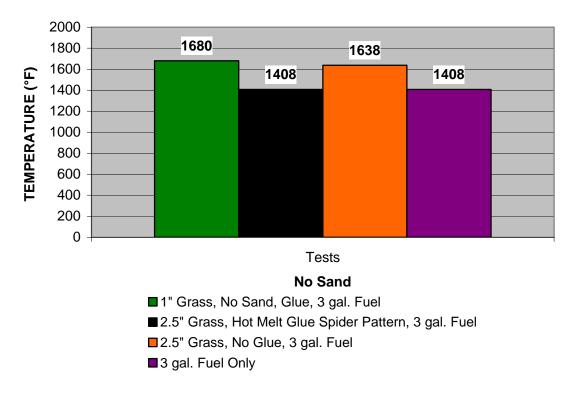
FIGURE D-34. PEAK TEMPERATURES (NO SAND INFILL)

The key objective of this round of demonstrations was to determine if either selected adhesive materials (rubberized or hot-melt glue) contributed to the fire intensity. Figures D-34 and D-35 show the peak temperatures of the samples without and with sand infill, respectively. As can be seen from these figures, the addition of the adhesive materials did not add to the fire intensity.

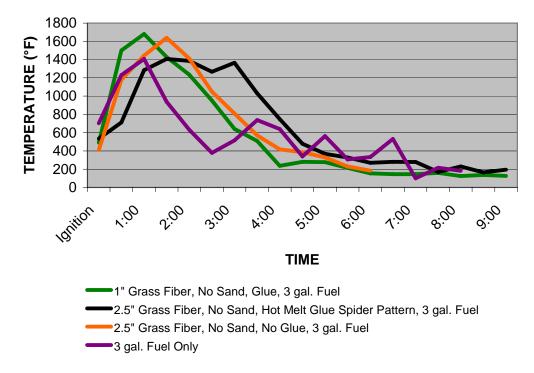
FIGURE D-36. TEMPERATURE VS TIME (NO SAND INFILL)

Figures D-36 and D-37 show the relationship of temperature and time during the demonstrations for samples without and with sand infill, respectively. It is apparent in these figures that adding the sand infill variable greatly affects the ability to have consistent and repeatable demonstrations. One key factor that was drawn from this data was that the fire burned longer due to the slower release of fuel vapors from the sand infill. The demonstrations with sand infill had a tendency to have initial peak intensity, fully involving the 4- by 8-ft sample, then declined into a fire that only involved portions of the sample. This added some subjectivity to the selection of areas to record the data. While the recorded temperatures for these demonstrations remained high well past the 20-minute mark, the overall intensity of the fire was lower, as shown in figure D-38.
